# Undersøkelse av tildekking av dypvannsdeponiet ved Malmøy- kalven med Sedimentprofilkamera

| <b>Tittel</b><br><br>Undersøkelse av tildekking av dypvannsdeponiet ved Malmøykalven med Sedimentprofilkamera | <b>Løpenr. (for bestilling)</b><br>5775-2009 | <b>Dato</b><br>31-03-2009 |

| <b>Oppdragsgiver(e)</b><br>Norges Geotekniske Institutt (NGI) | <b>Oppdragsreferanse</b><br>Arne Pettersen og Espen Eek |

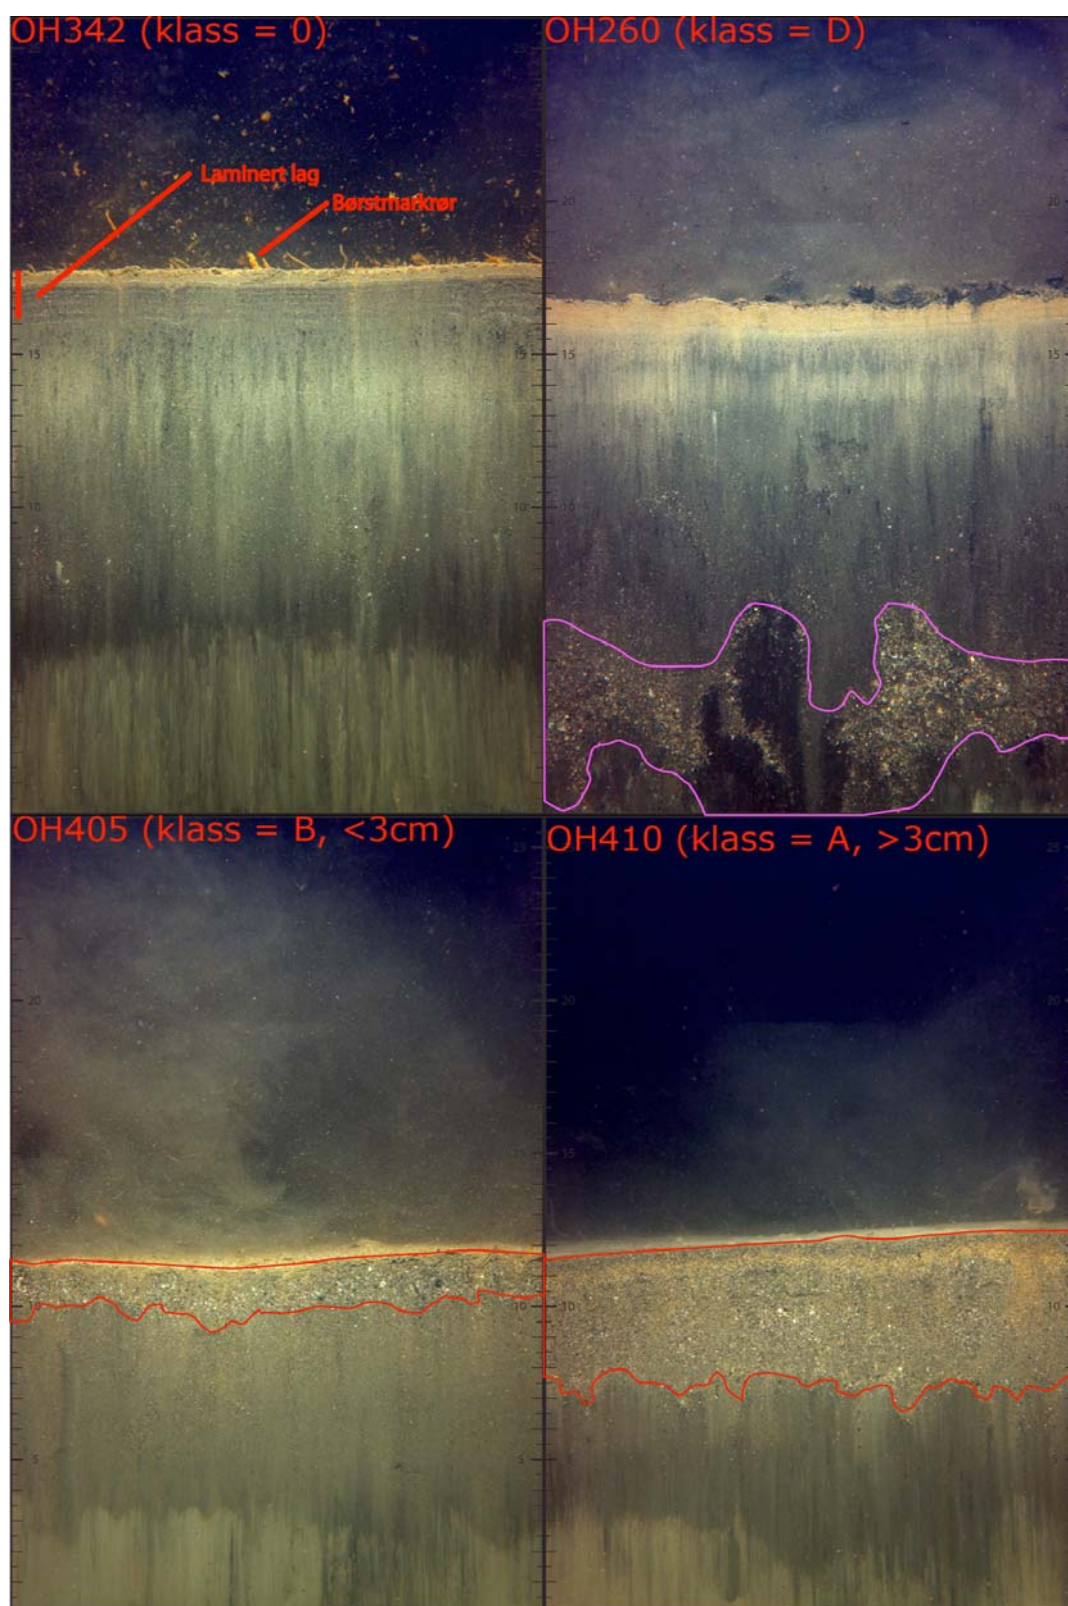
**Figur 3.** Sedimentprofilbilder fra 4 stasjoner representative for de forskjellige klassene (A, B, D og 0, se tekst). Rød og rosa markering viser utbredelsen av tildekkingsmateriale. I bildet fra stasjon uten tildekkingsmateriale (klasse 0) vises laminering nær sedimentoverflaten og børstemarkrør. Langs sidene på hvert bilde vises en cm-skala (2 streker = 1 cm).

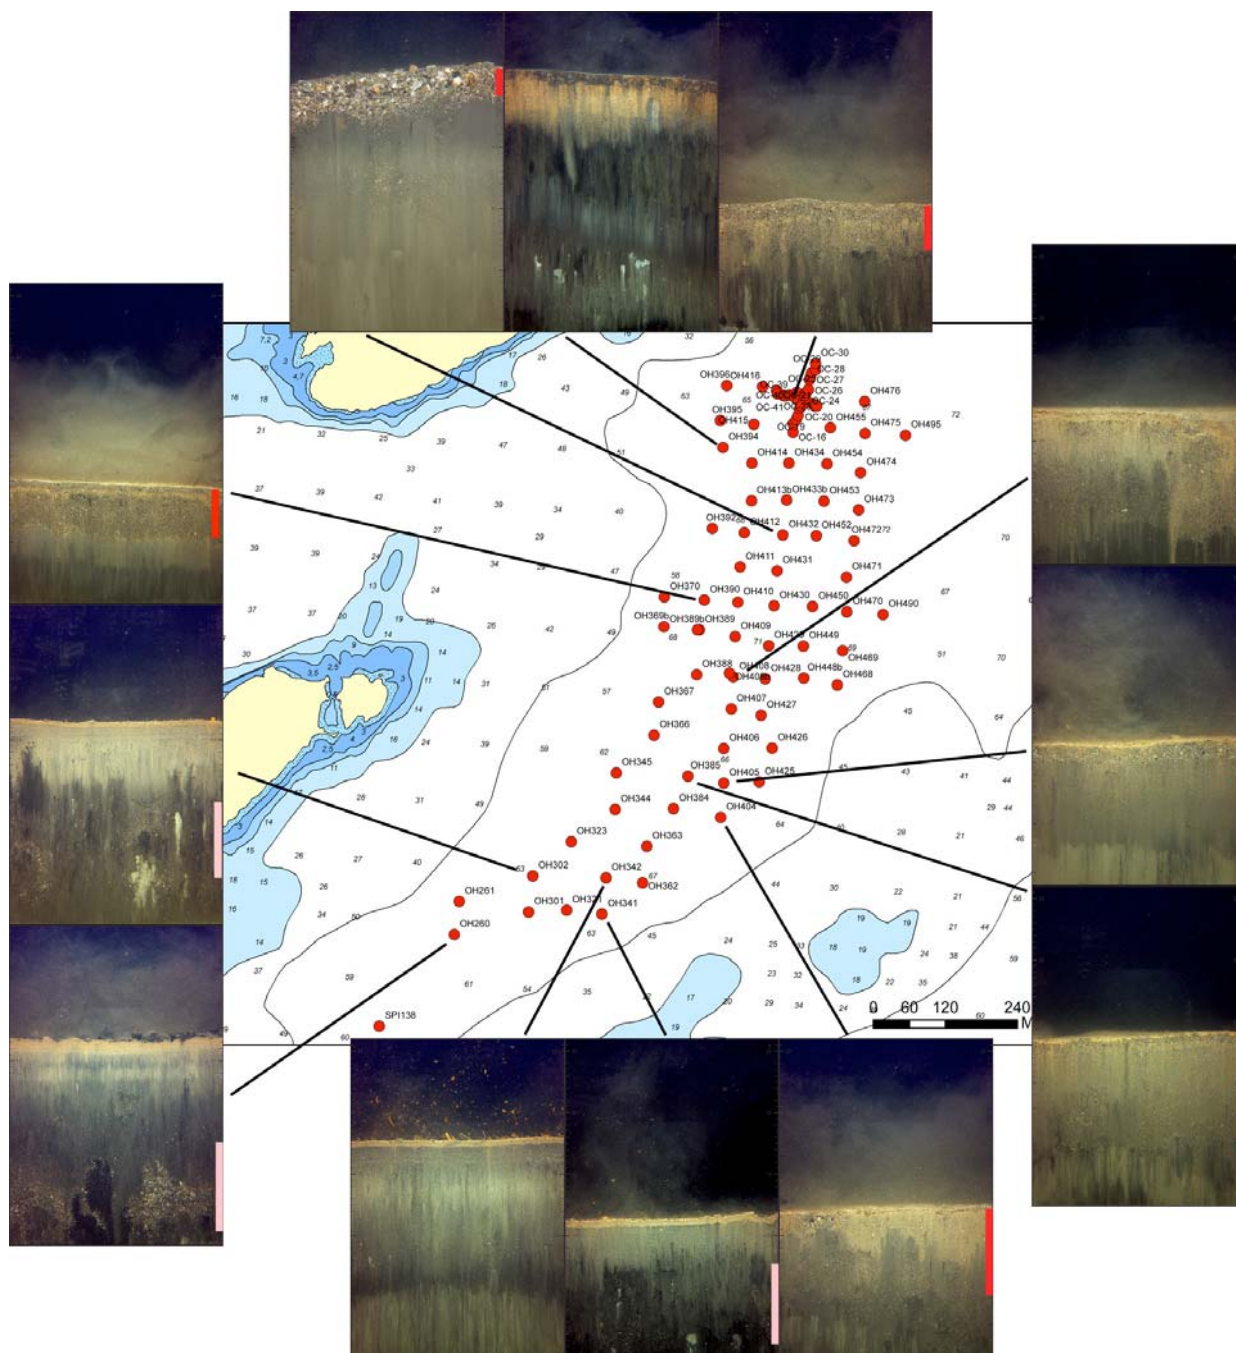
**Figur 4.** Sedimentprofilbilder fra utvalgte stasjoner. Røde streker markerer dekklagets tykkelse på klasse A- eller B-stasjoner. Rosa streker markerer tykkelse av overdekket dekklag på klasse D stasjoner. På bilder uten markering ble det ikke observert spor av tildekkingsmasser (klasse 0).

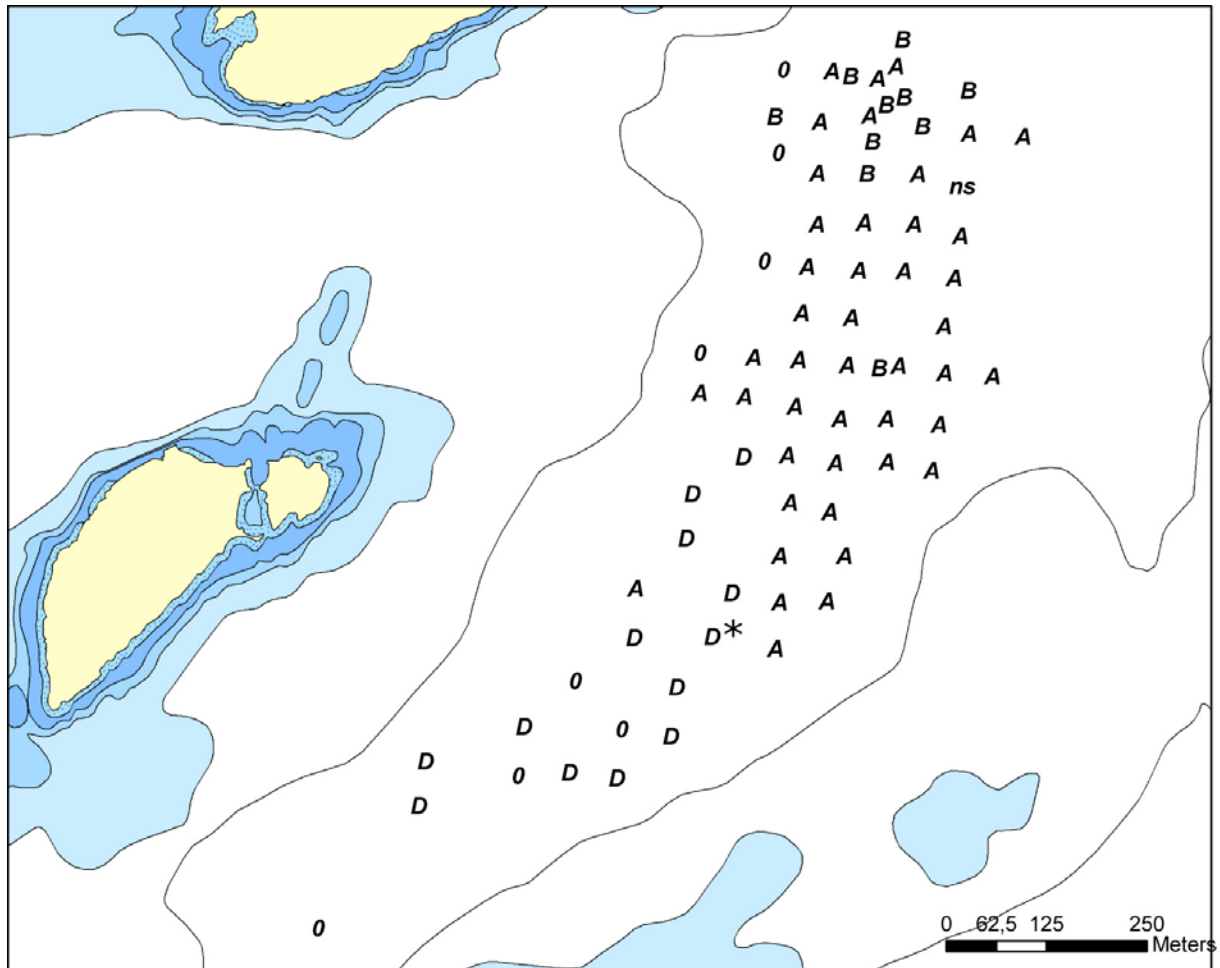
**Figur 5** viser at klasse D og klasse 0 dominerte i den søndre delen av deponiområdet, dvs syd og vest for stasjon OH 388. I tillegg ble det observert klasse 0 på 4 stasjoner langs vestsiden av deponiet. Disse fire stasjonene (OH396, OH394, OH392 og OH370) var lokalisert i den relativt skarpe overgangen mellom det flate deponiområdet og den tilstøtende bassengskrånningen. Dette ses best på kart med ekvidistanse 1 m (Hauge m. fl. 2009, kartbilag 01).

**Figur 5.** Klassifisering av sedimentene i deponiområdet på grunnlag av SPI-bilder i januar 2009. **0** = ingen observasjon av tildekkingsmateriale, **D** er dekkmasser overdekket med finkornt sediment, **B** er tildekket med < 3 cm tildekkingsmateriale på toppen av sedimentet, **A** er tildekket med ≥ 3 cm tildekkingsmateriale på toppen av sedimentet, **ns** = ingen penetrasjon. \*Stasjon O384/SPI129 se **figur 6**.

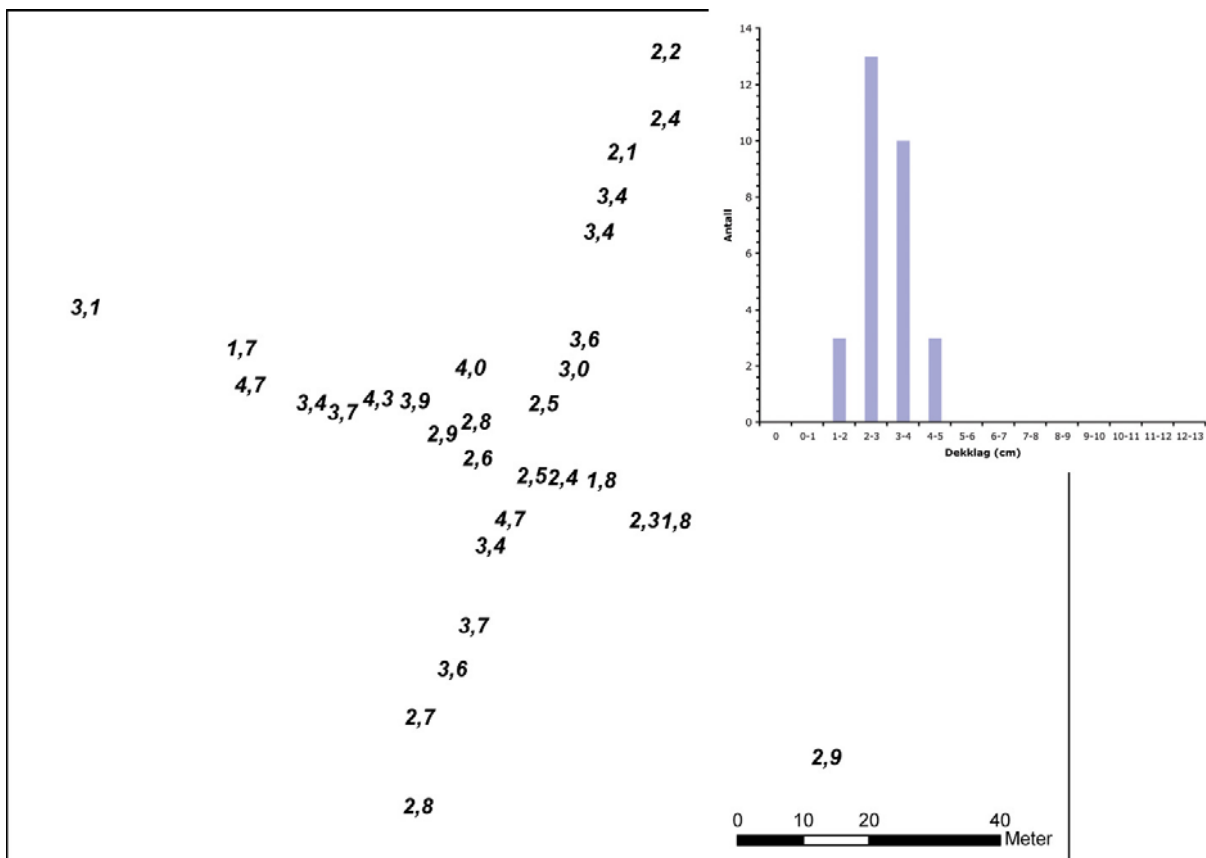
**Figur 8.** Tildekkingslagets tykkelse (cm) i undersøkelsesområdet for Opticap-prosjektet. Histogrammet viser frekvensen av de forskjellige tykkelsene av tildekkingsmaterial.

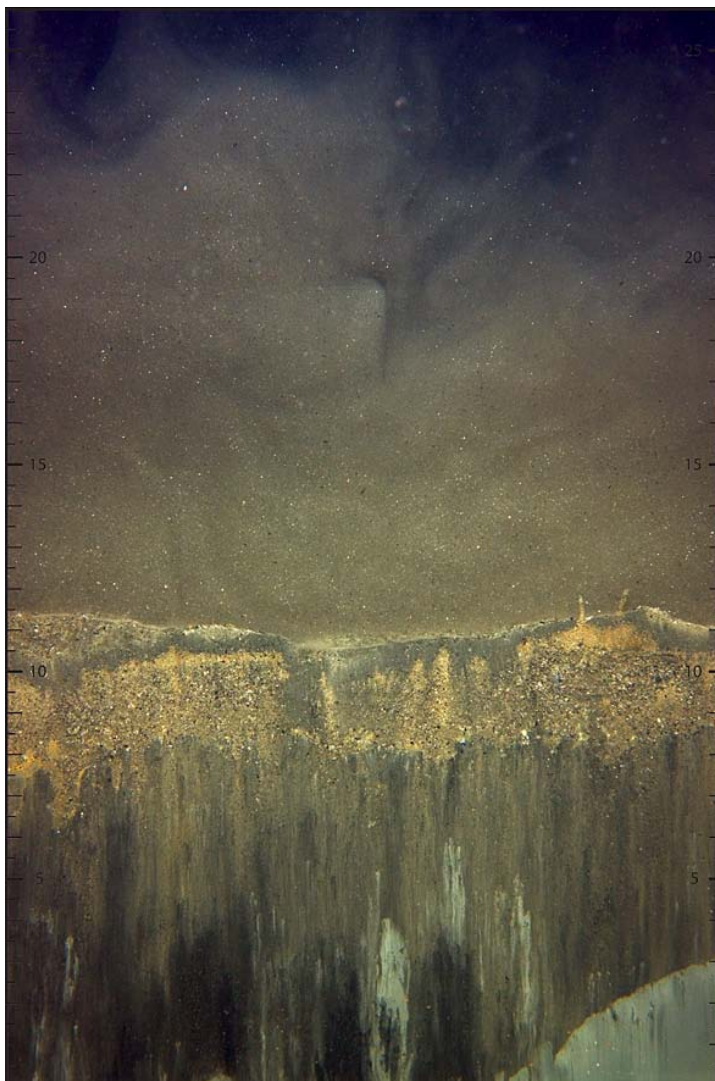
# OC-16 SPI Malmøykalven NGI Opticap

Penetration depth (cm) 11,0  
Sediment roughness (cm) 0,5  
SPI weight SPI 26 kg

Cap crest (cm) 0,0  
Cap area (cm<sup>2</sup>) 48,0  
Cap thickness (cm) 2,8
