# Undersøkelse av tildekking av dypvannsdeponiet ved Malmøy- kalven med Sedimentprofilkamera

| <b>Tittel</b><br><br>Undersøkelse av tildekking av dypvannsdeponiet ved Malmøykalven med Sedimentprofilkamera | <b>Løpenr. (for bestilling)</b><br>5775-2009 | <b>Dato</b><br>31-03-2009 |

| <b>Oppdragsgiver(e)</b><br>Norges Geotekniske Institutt (NGI) | <b>Oppdragsreferanse</b><br>Arne Pettersen og Espen Eek |

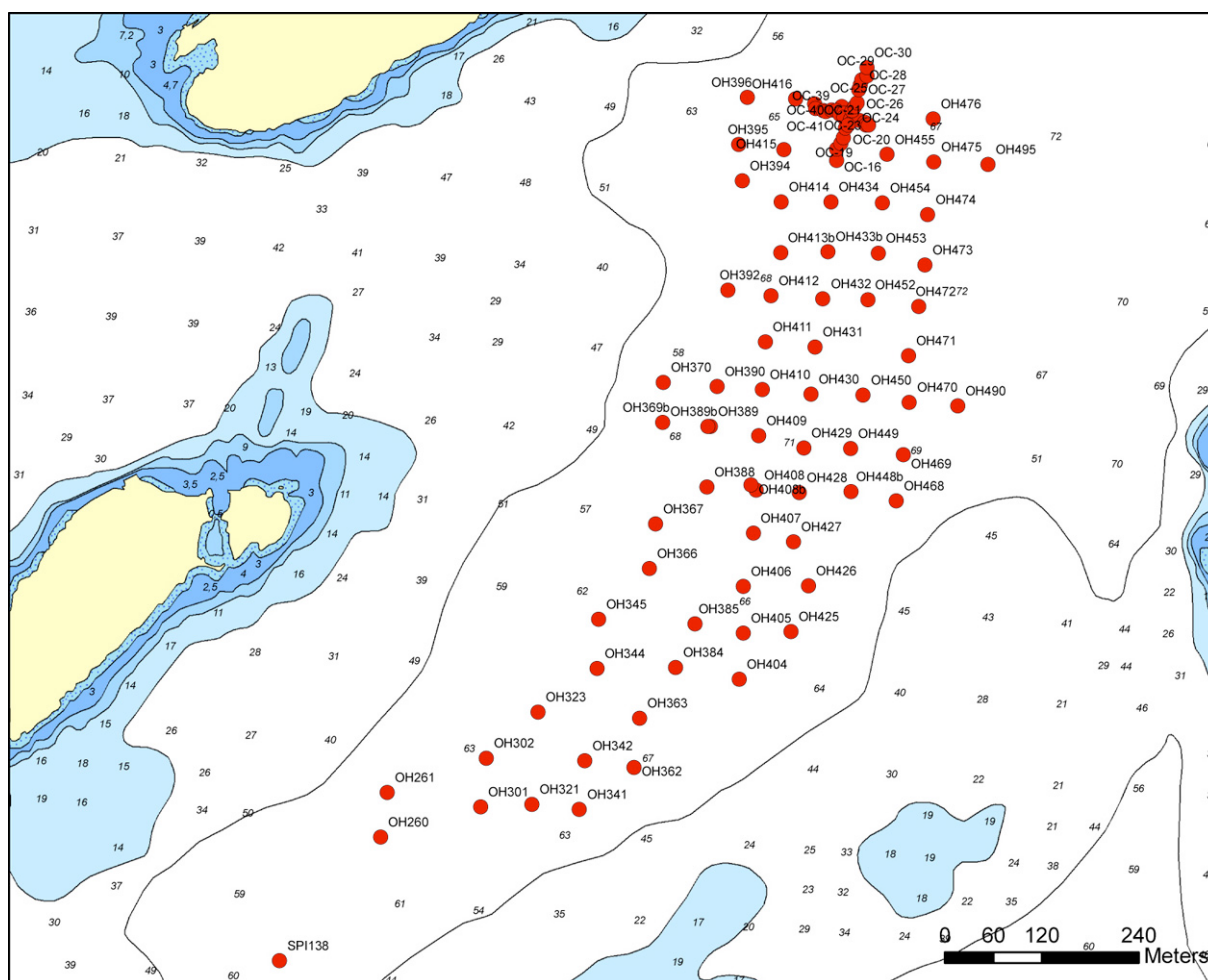
**Figur 1.** Stasjoner i Malmøykalven prøvetatt med SPI-kamera i januar 2009. Stasjonene for Oslo Havn-undersøkelsen (OH) ble utlagt med 60 m standard avstand (O-28477), mens stasjonene undersøkt i regi av OPTICAP (OC) ble utlagt med standard 6 m mellom hver stasjon (O-28478). Stasjon SPI138 (nederst venstre) er en referansestasjon utenfor selve deponiområdet.

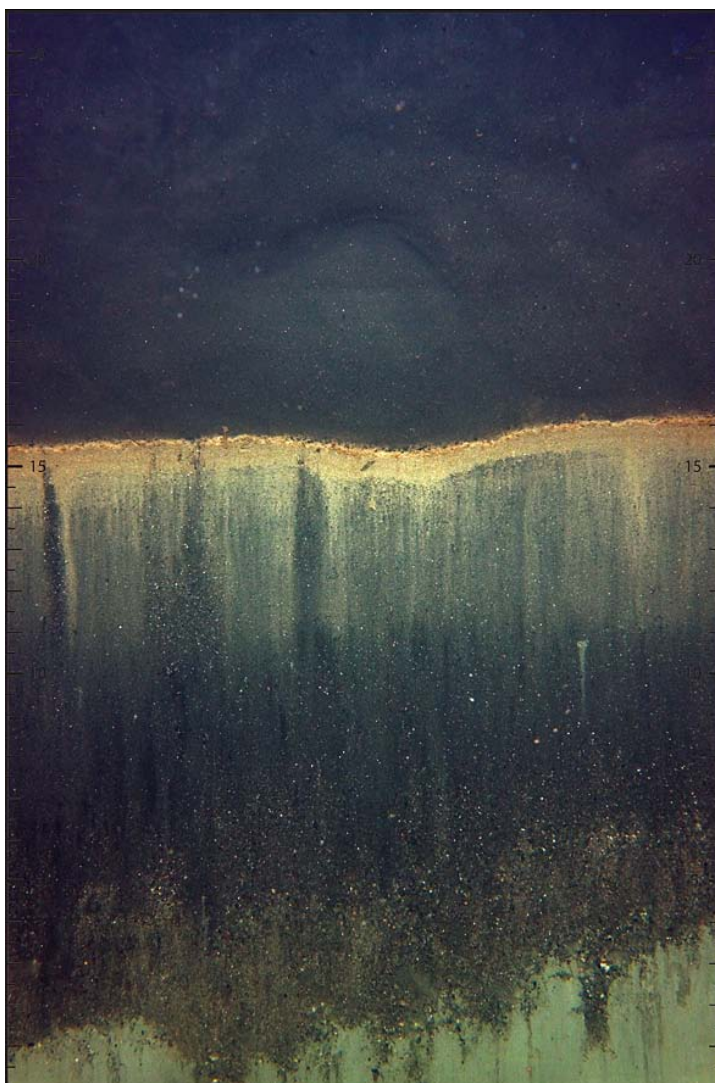
Image ID 4090  
 OH261\_2.jpg

Penetration depth (cm) 15,5  
 Sediment roughness (cm) 0,5  
 SPI weight SPI 26 kg

Cap crest (cm) 9,0  
 Cap area (cm<sup>2</sup>) 90,0  
 Cap thickness (cm) 5,2

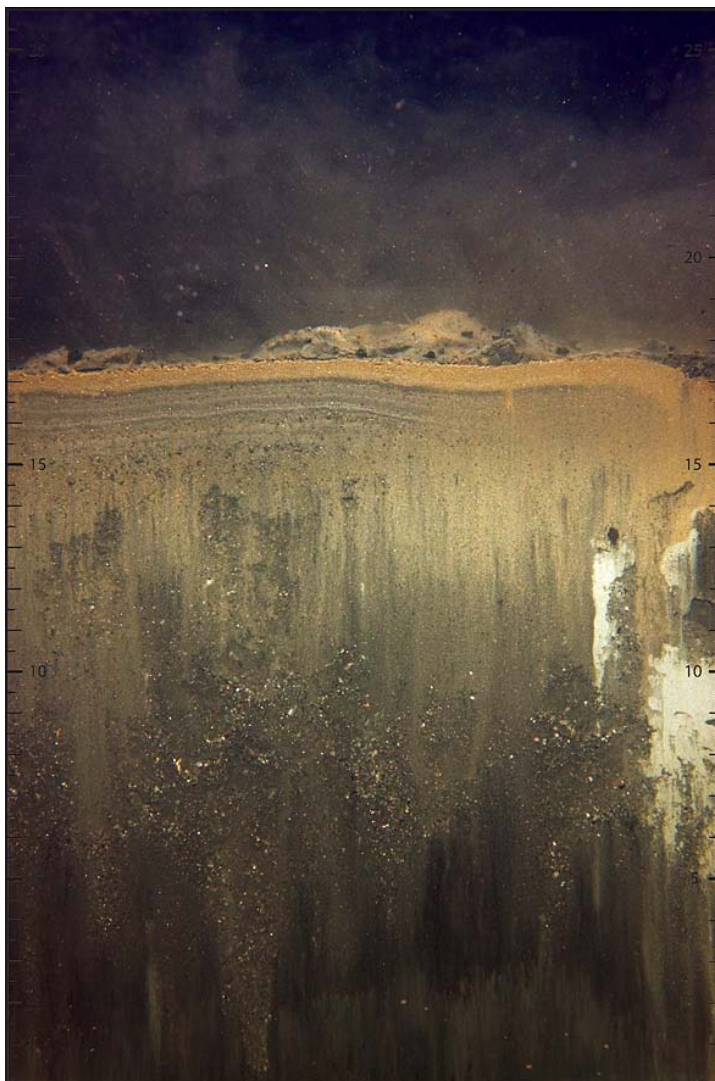
Image ID 4094  
OH321\_1.jpg

Penetration depth (cm) 17,0 Cap crest (cm) 3,3  
Sediment roughness (cm) 0,5 Cap area (cm<sup>2</sup>) 59,0  
SPI weight SPI 26 kg Cap thickness (cm) 3,4

Color sediment layer 1 Sort  
Color sediment layer 2

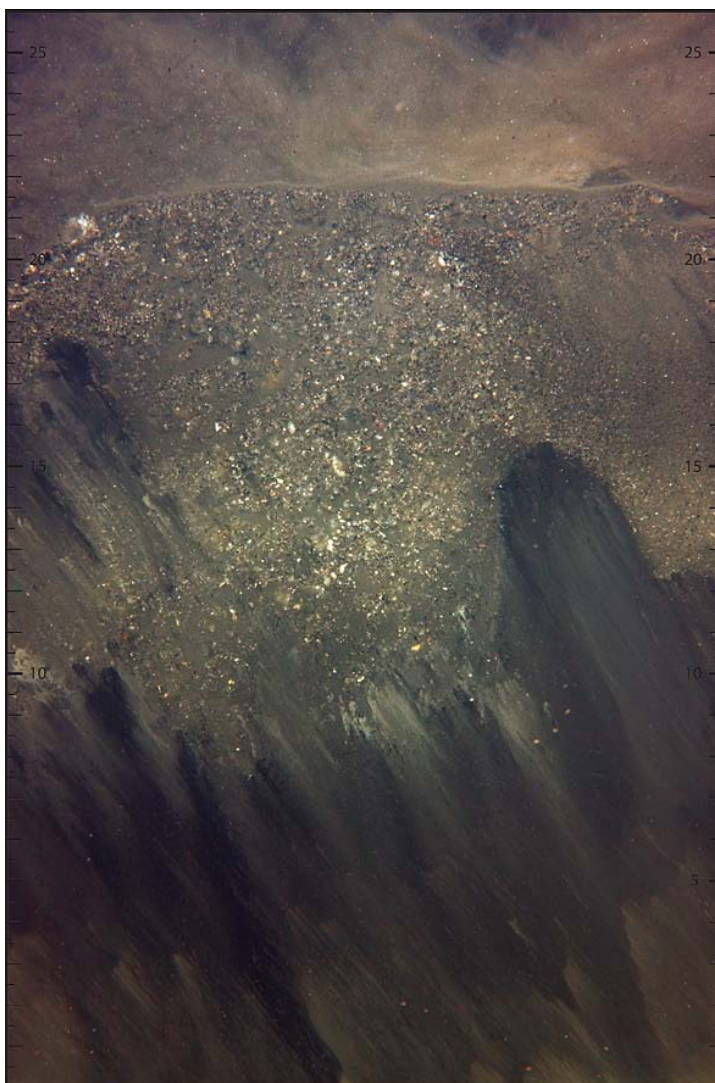
Image ID 4099  
 OH345\_1.jpg

Penetration depth (cm) 21,0 Cap crest (cm) 0,0  
 Sediment roughness (cm) 2,0 Cap area (cm<sup>2</sup>) 143,0  
 SPI weight SPI 26 kg Cap thickness (cm) 8,3

Color sediment layer 1 Sort  
 Color sediment layer 2

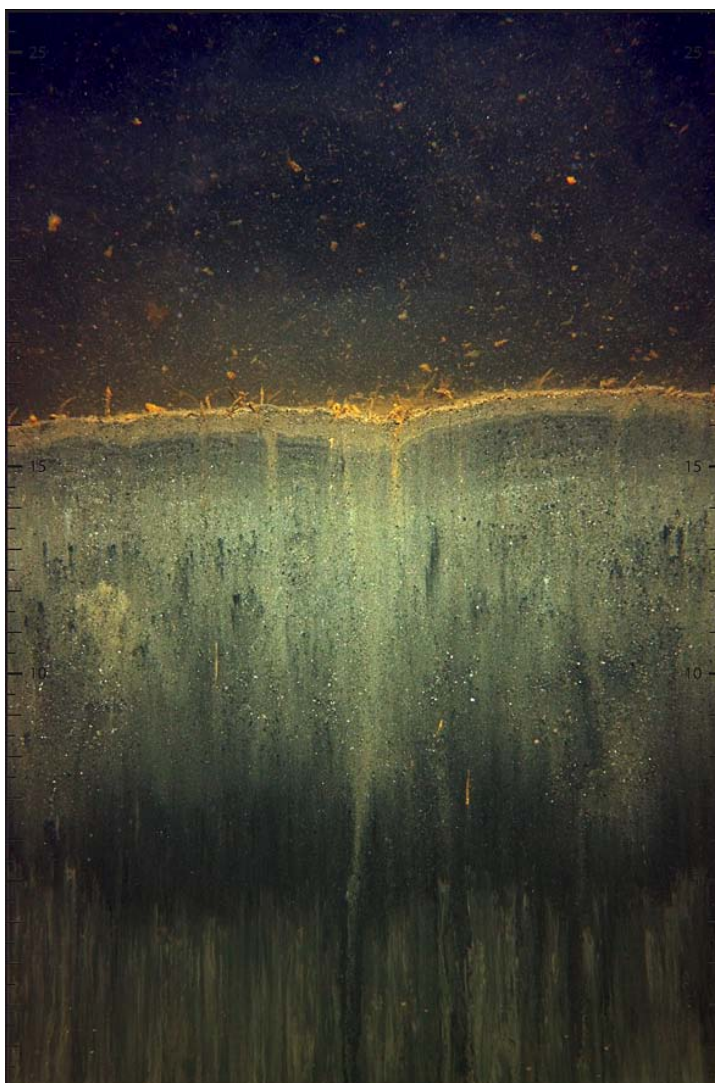
# OH363 SPI NGI Malmøykalven Oslo Havn

Penetration depth (cm) 16,5  
Sediment roughness (cm) 0,5  
SPI weight SPI 26 kg

Cap crest (cm) 2,5  
Cap area (cm<sup>2</sup>) 56,0  
Cap thickness (cm) 3,2

Color sediment layer 1 Sort  
Color sediment layer 2 Mørkgrå

Biogen. stucture Børstmarkrør

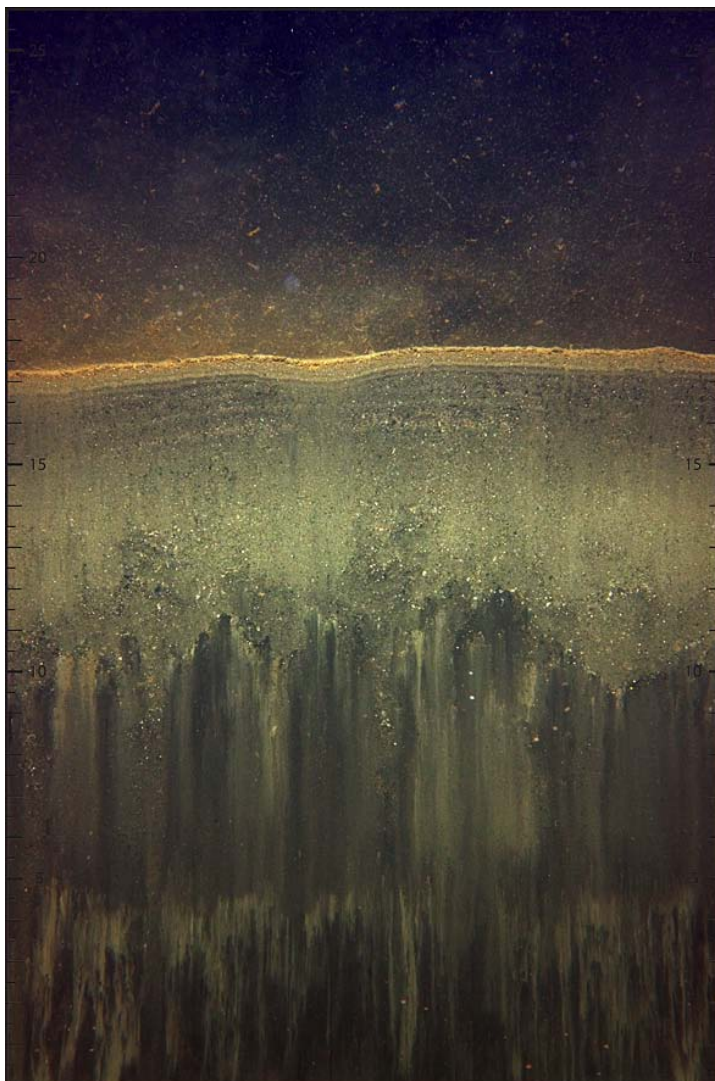
# OH366 SPI NGI Malmøykalven Oslo Havn

| Penetration depth (cm) | 17,5 | Cap crest (cm) | 1,0 |
| Sediment roughness (cm) | 0,5 | Cap area (cm <sup>2</sup> ) | 85,0 |
| SPI weight | SPI 26 kg | Cap thickness (cm) | 4,9 |

Color sediment layer 1 Sort  
Color sediment layer 2

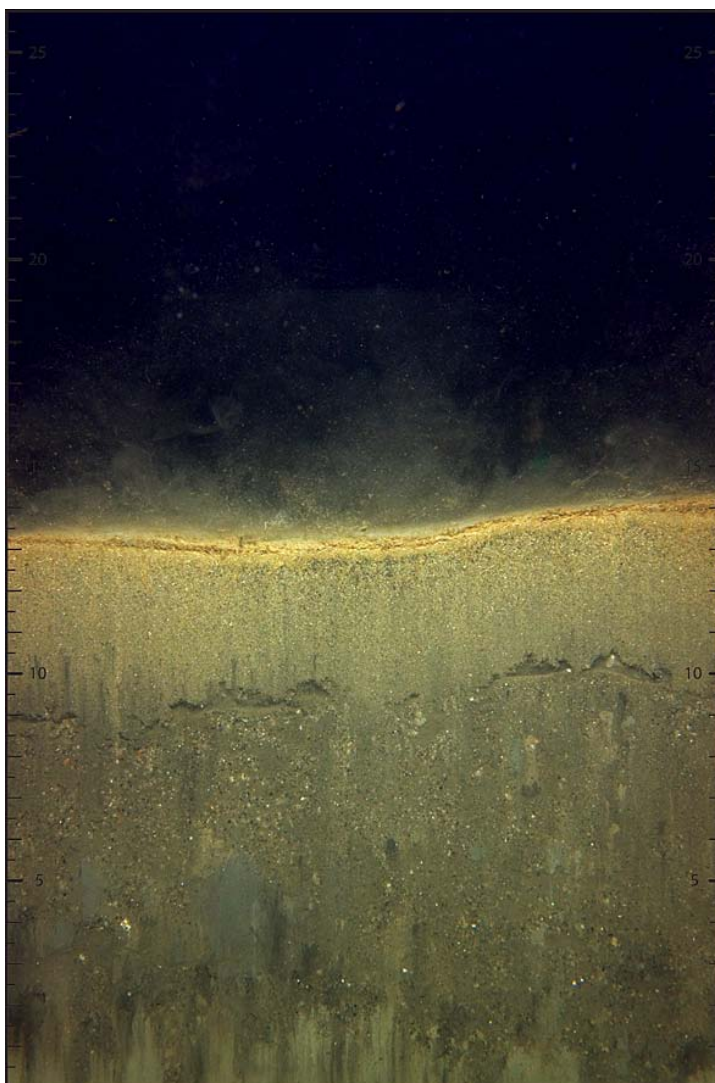
# OH367 SPI NGI Malmøykalven Oslo Havn

| Penetration depth (cm) | 13,5 | Cap crest (cm) | 3,0 |
| Sediment roughness (cm) | 0,5 | Cap area (cm <sup>2</sup> ) | 123,0 |
| SPI weight | SPI 26 kg | Cap thickness (cm) | 7,1 |

Color sediment layer 1 Mørkgrå  
Color sediment layer 2

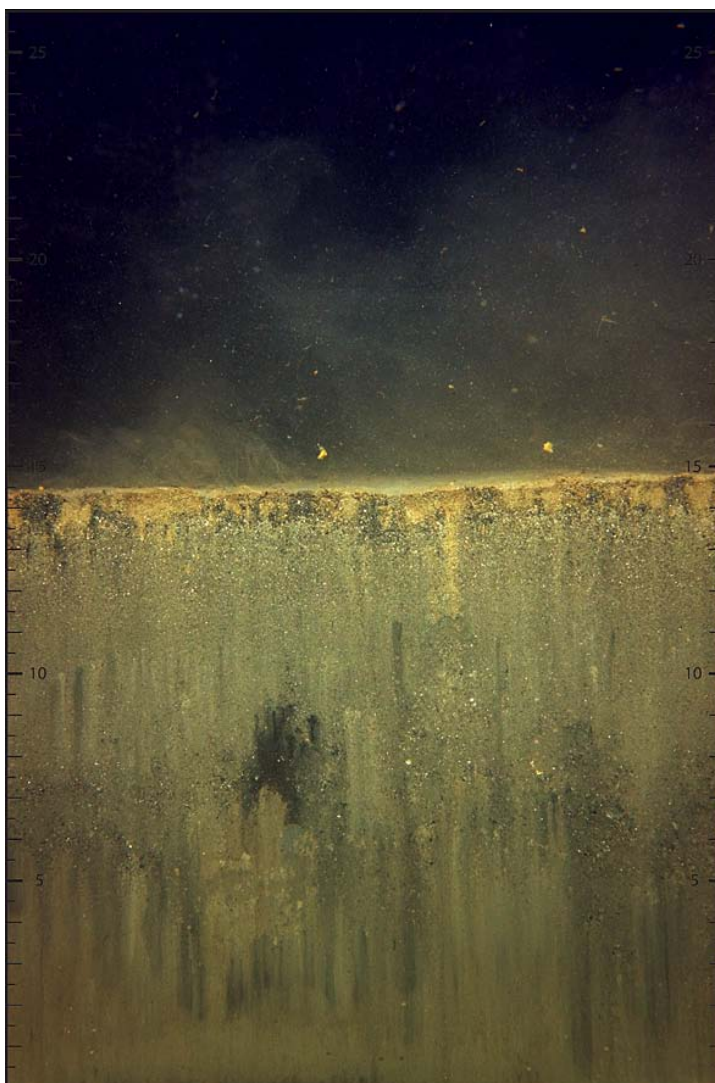
# OH369b SPI NGI Malmøykalven Oslo Havn

Penetration depth (cm) 14,5  
Sediment roughness (cm) 0,0  
SPI weight SPI 26 kg

Cap crest (cm) 1,0  
Cap area (cm<sup>2</sup>) 126,0  
Cap thickness (cm) 7,3

Color sediment layer 1 Mørkgrå  
Color sediment layer 2

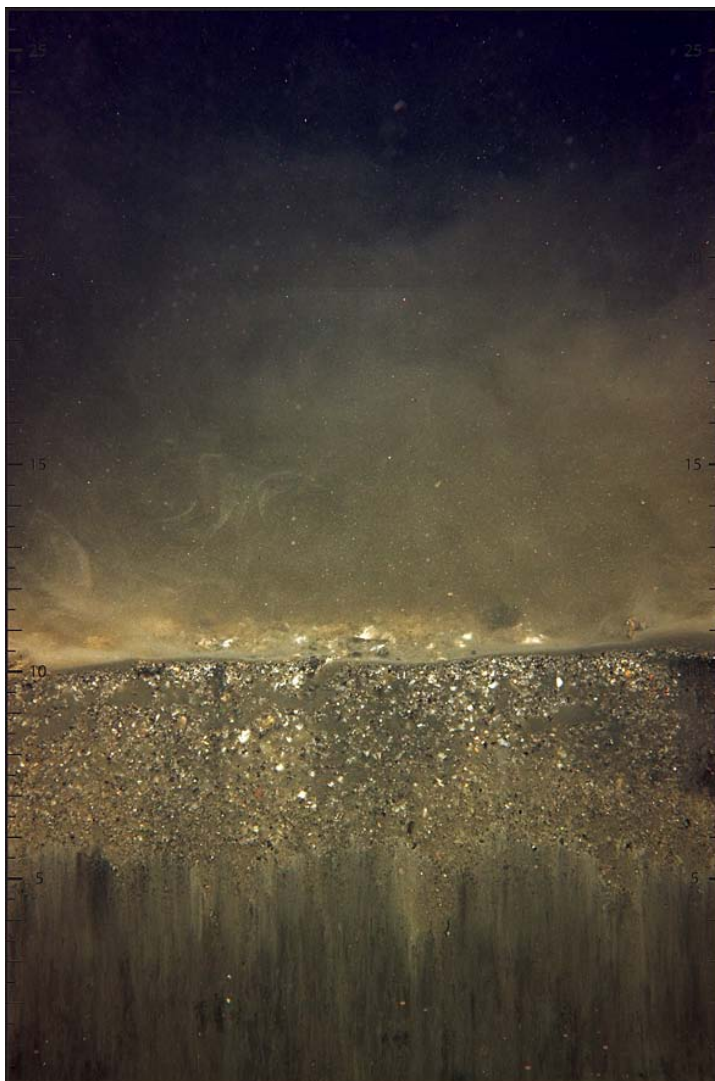
# OH370 SPI NGI Malmøykalven Oslo Havn

| Penetration depth (cm) | 10,0 | Cap crest (cm) | 0,0 |
| Sediment roughness (cm) | 0,0 | Cap area (cm <sup>2</sup> ) | 84,0 |
| SPI weight | SPI 26 kg | Cap thickness (cm) | 4,9 |

Color sediment layer 1 Mørkgrå  
Color sediment layer 2 Sort

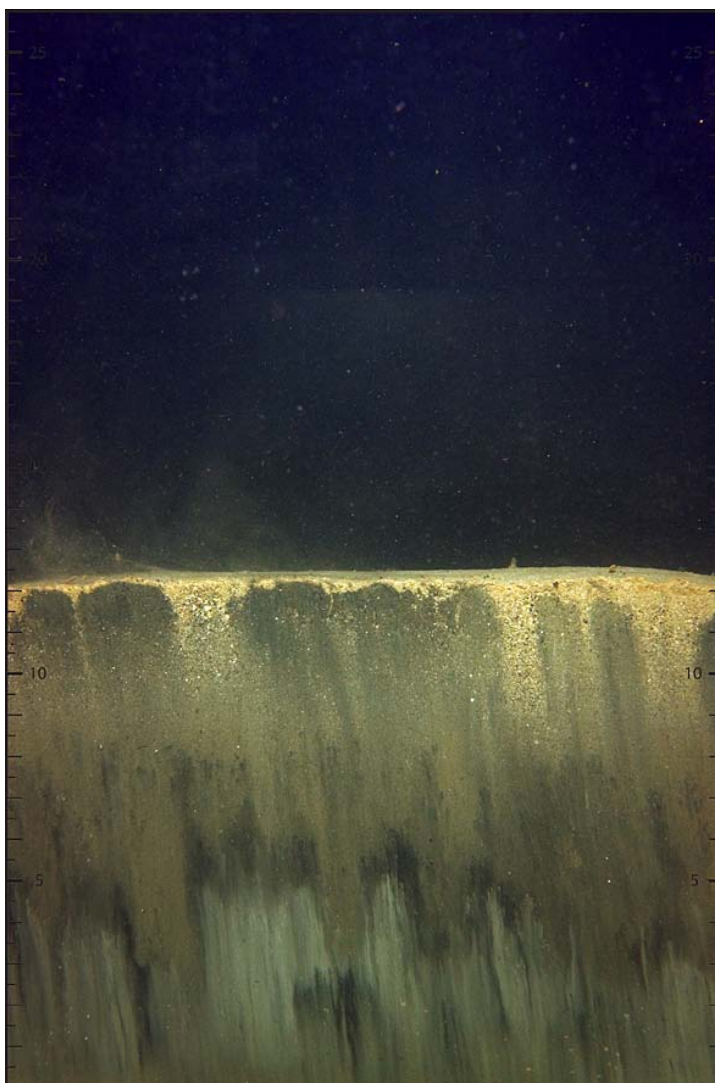
# OH384 SPI NGI Malmøykalven Oslo Havn

Penetration depth (cm) 12,0  
Sediment roughness (cm) 0,0  
SPI weight SPI 26 kg

Cap crest (cm)  
Cap area (cm<sup>2</sup>) 0,0  
Cap thickness (cm) 0,0

Color sediment layer 1 Mørkgrå  
Color sediment layer 2 Lysgrå

Biogen. stucture Børstmarkrør

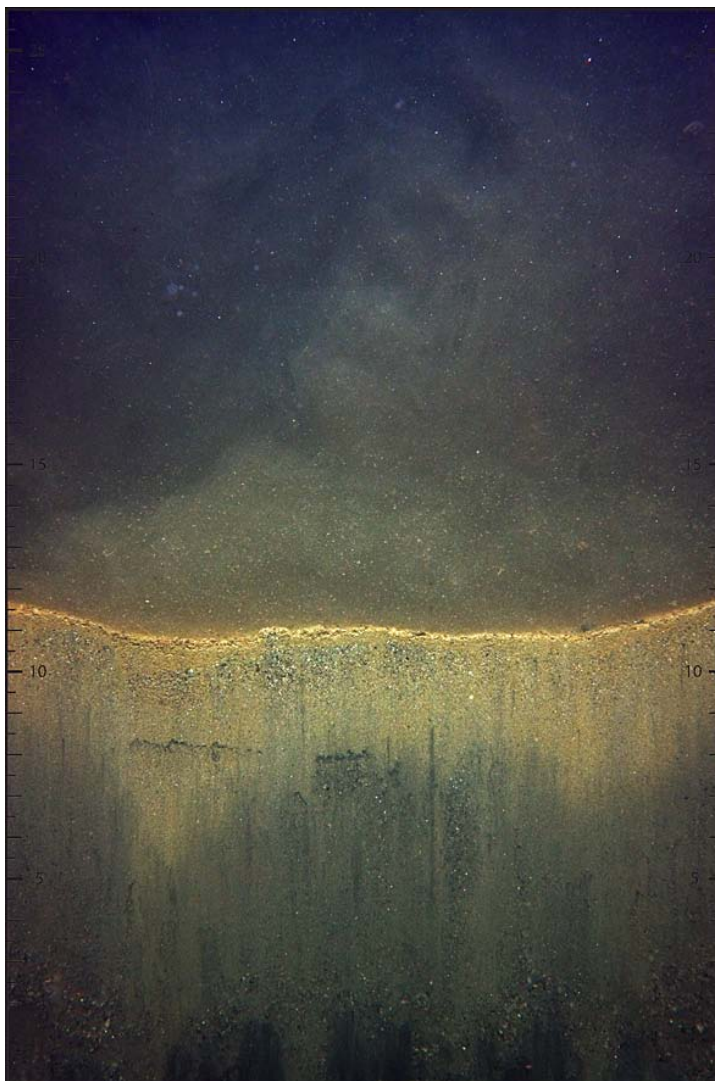
# OH385 SPI NGI Malmøykalven Oslo Havn

| Penetration depth (cm) | 11,0 | Cap crest (cm) | 2,5 |
| Sediment roughness (cm) | 1,0 | Cap area (cm <sup>2</sup> ) | 94,0 |
| SPI weight | SPI 26 kg | Cap thickness (cm) | 5,4 |

Color sediment layer 1 Sort  
Color sediment layer 2

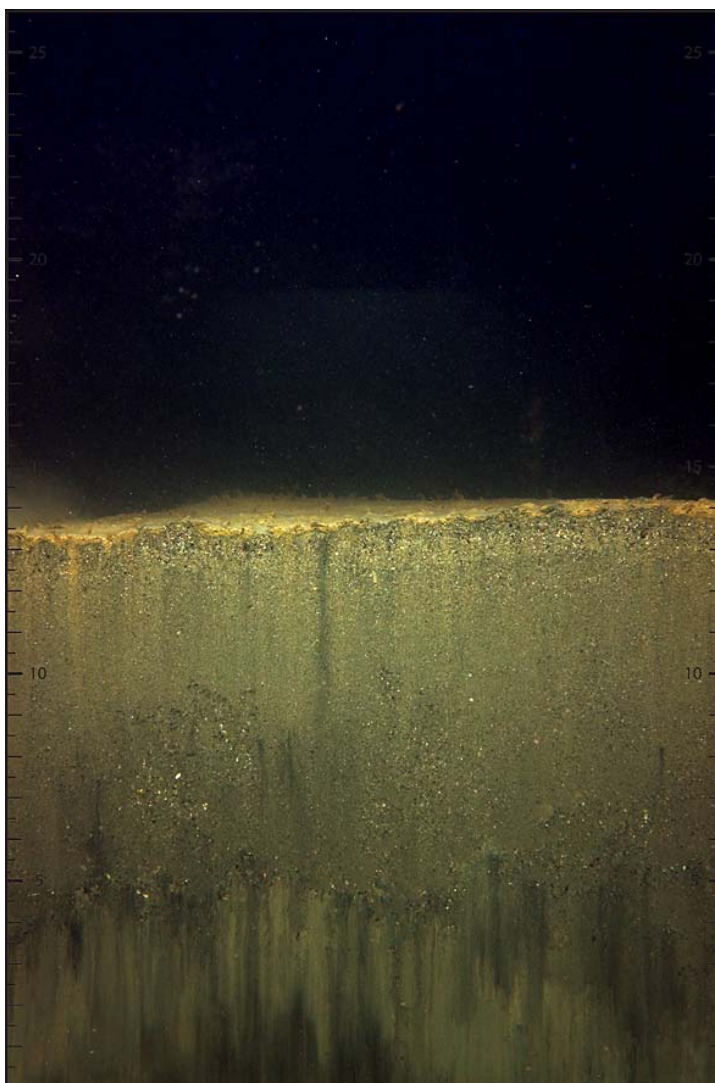
# OH388 SPI NGI Malmøykalven Oslo Havn

| Penetration depth (cm) | 14,0 |

| Cap crest (cm) | 3,5 |
| Cap area (cm <sup>2</sup> ) | 74,0 |
| Cap thickness (cm) | 4,3 |

Color sediment layer 1 Mørkgrå  
Color sediment layer 2

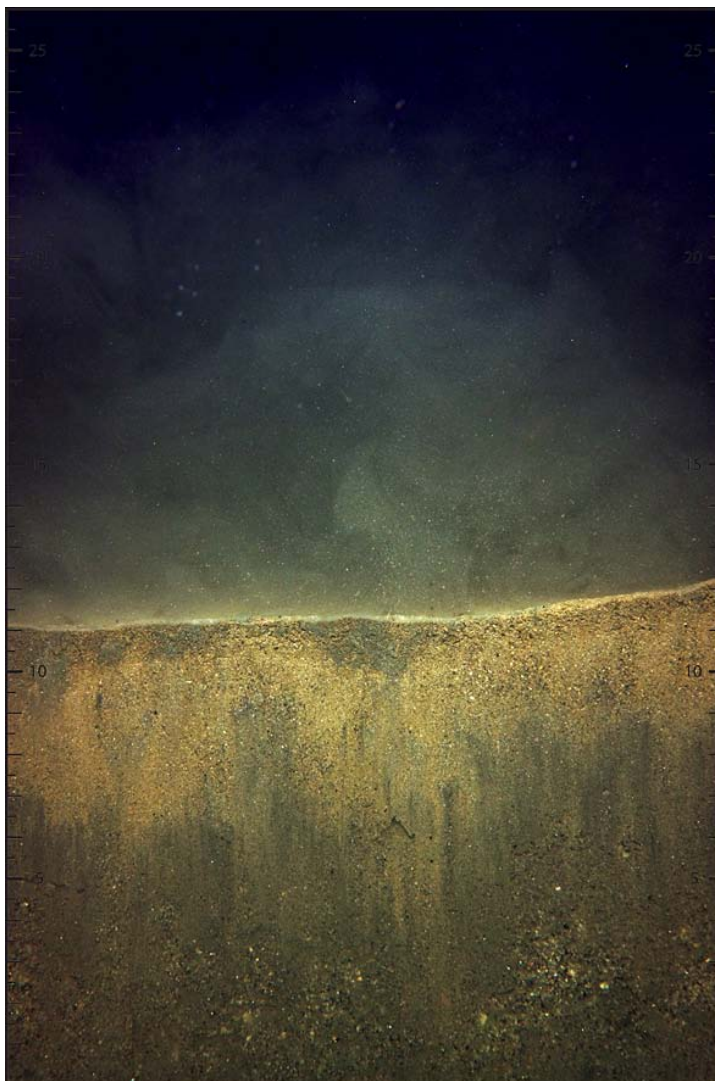
# OH389b SPI NGI Malmøykalven Oslo Havn

| Penetration depth (cm) | 11,5 | Cap crest (cm) | 5,0 |
| Sediment roughness (cm) | 1,0 | Cap area (cm <sup>2</sup> ) | 85,0 |
| SPI weight | SPI 26 kg | Cap thickness (cm) | 4,9 |

Color sediment layer 1 Mørkgrå  
Color sediment layer 2

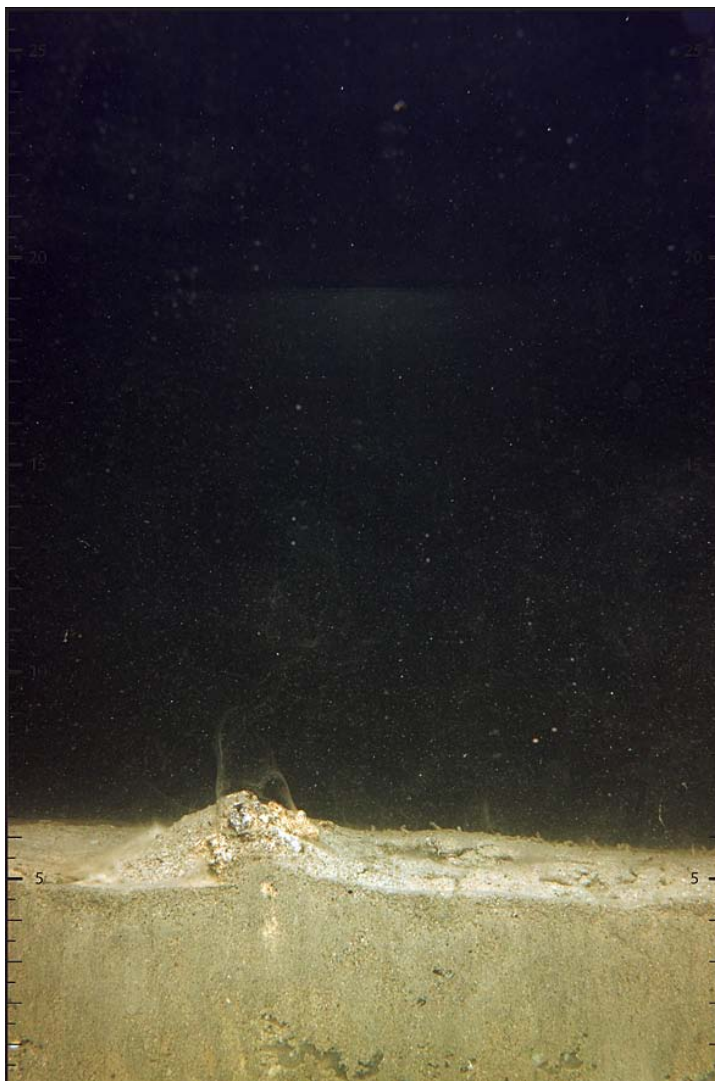
Image ID 4148  
 OH448b\_2.jpg

Penetration depth (cm) 5,0 Cap crest (cm) 0,0  
 Sediment roughness (cm) 2,0 Cap area (cm<sup>2</sup>) 85,0  
 SPI weight SPI 16,8 kg Cap thickness (cm) 4,9

Color sediment layer 1 Lysgrå  
 Color sediment layer 2

Biogen. structure Børstmarkrør

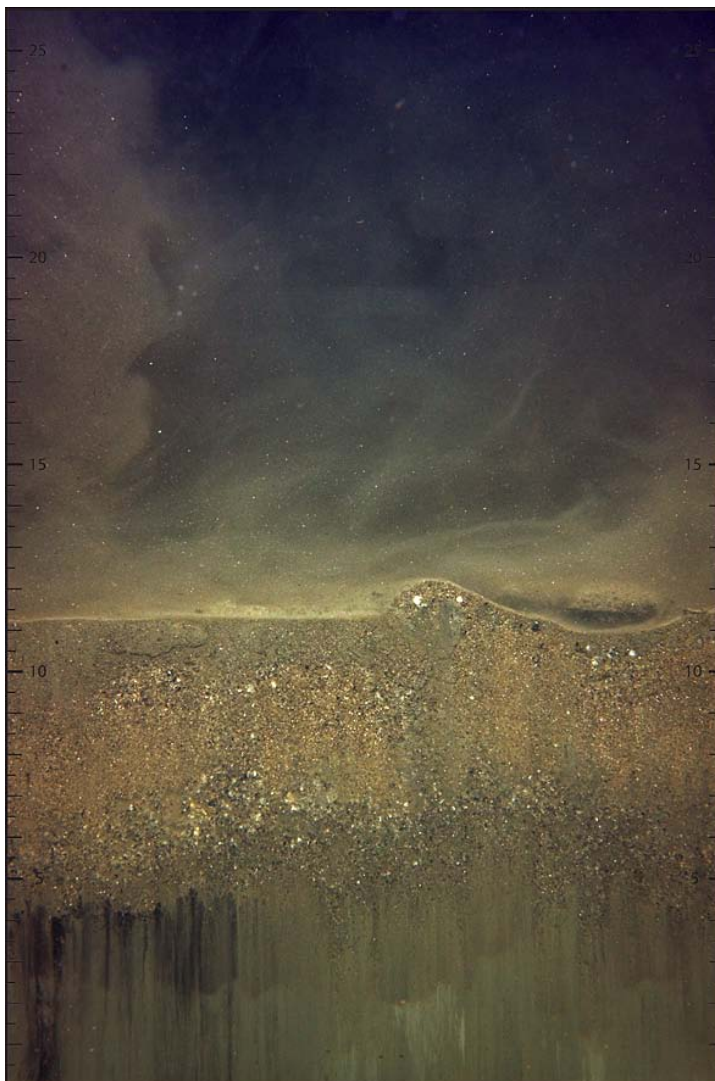
Image ID 4126  
OH449\_1.jpg

| Penetration depth (cm) | 11,5 | Cap crest (cm) | 0,0 |
| Sediment roughness (cm) | 1,0 | Cap area (cm <sup>2</sup> ) | 107,0 |
| SPI weight | SPI 26 kg | Cap thickness (cm) | 6,2 |

Color sediment layer 1 Sort  
Color sediment layer 2 Mørkgrå

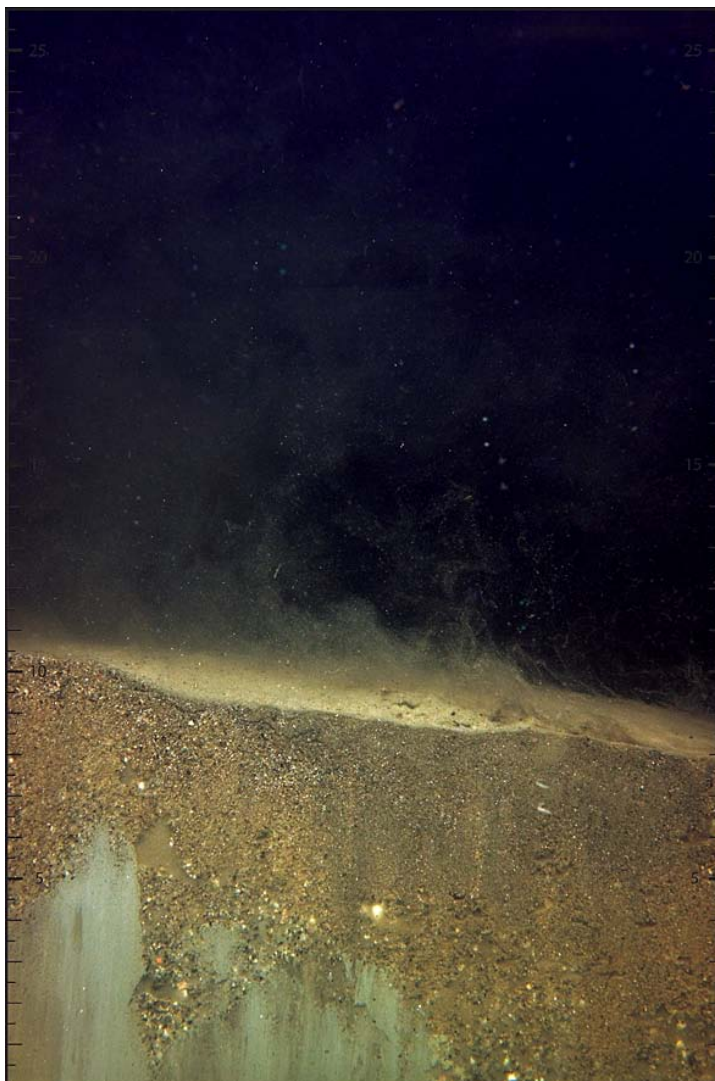
Image ID 4127  
OH450\_3.jpg

| Penetration depth (cm) | 9,0 | Cap crest (cm) | 0,0 |
| Sediment roughness (cm) | 2,5 | Cap area (cm <sup>2</sup> ) | 123,0 |
| SPI weight SPI 26 kg | | Cap thickness (cm) | 7,1 |

Color sediment layer 1 Lysgrå  
Color sediment layer 2

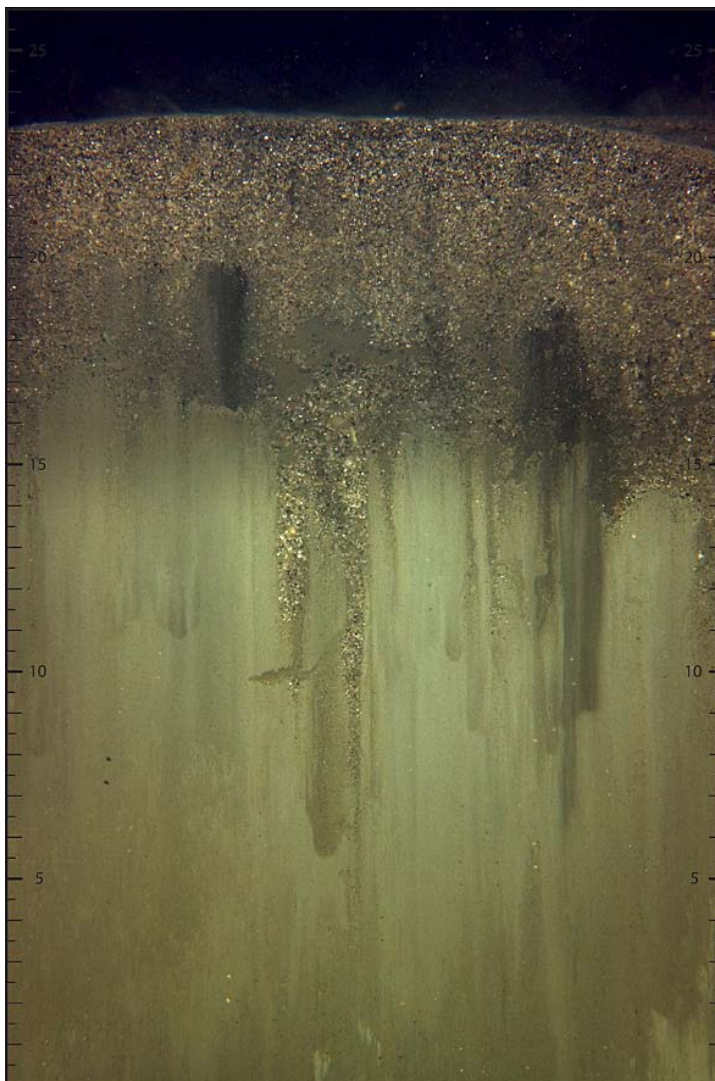
Image ID 4149  
OH452\_1.jpg

| Penetration depth (cm) | 23,0 | Cap crest (cm) | 0,0 |
| Sediment roughness (cm) | 0,0 | Cap area (cm <sup>2</sup> ) | 133,0 |
| SPI weight SPI 26 kg | | Cap thickness (cm) | 7,7 |

Color sediment layer 1 Lysgrå  
Color sediment layer 2

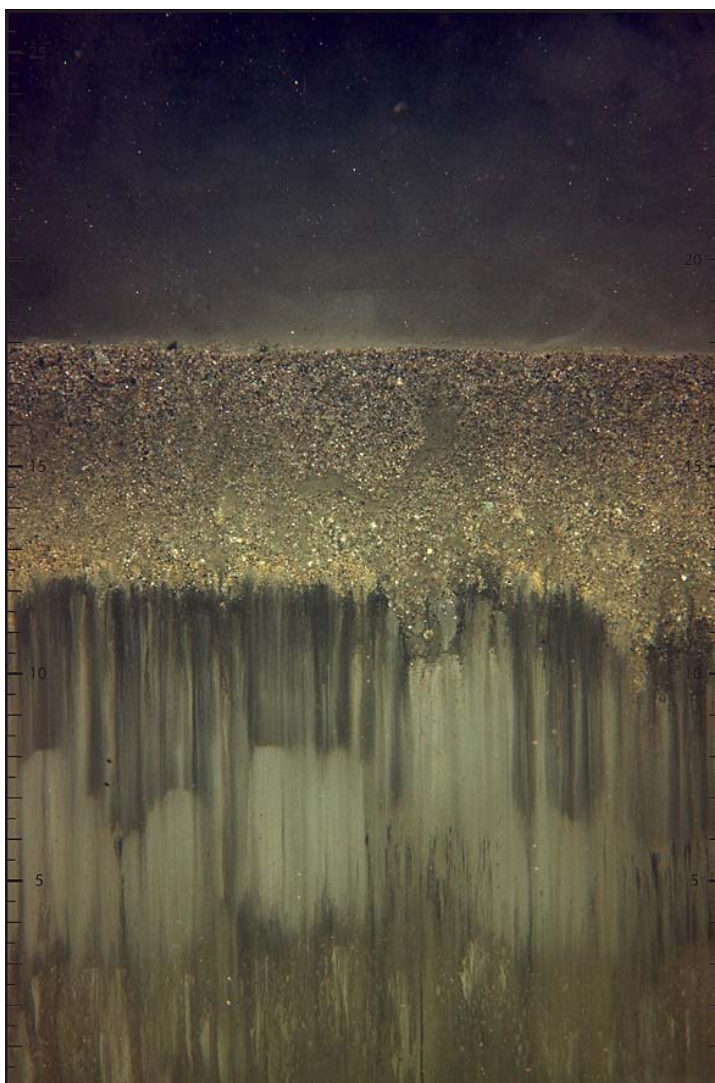
Image ID 4150  
 OH453\_1.jpg

Penetration depth (cm) 18,0 Cap crest (cm) 0,0  
 Sediment roughness (cm) 0,0 Cap area (cm<sup>2</sup>) 102,0  
 SPI weight SPI 16,8 kg Cap thickness (cm) 5,9

Color sediment layer 1 Sort  
 Color sediment layer 2 Lysgrå

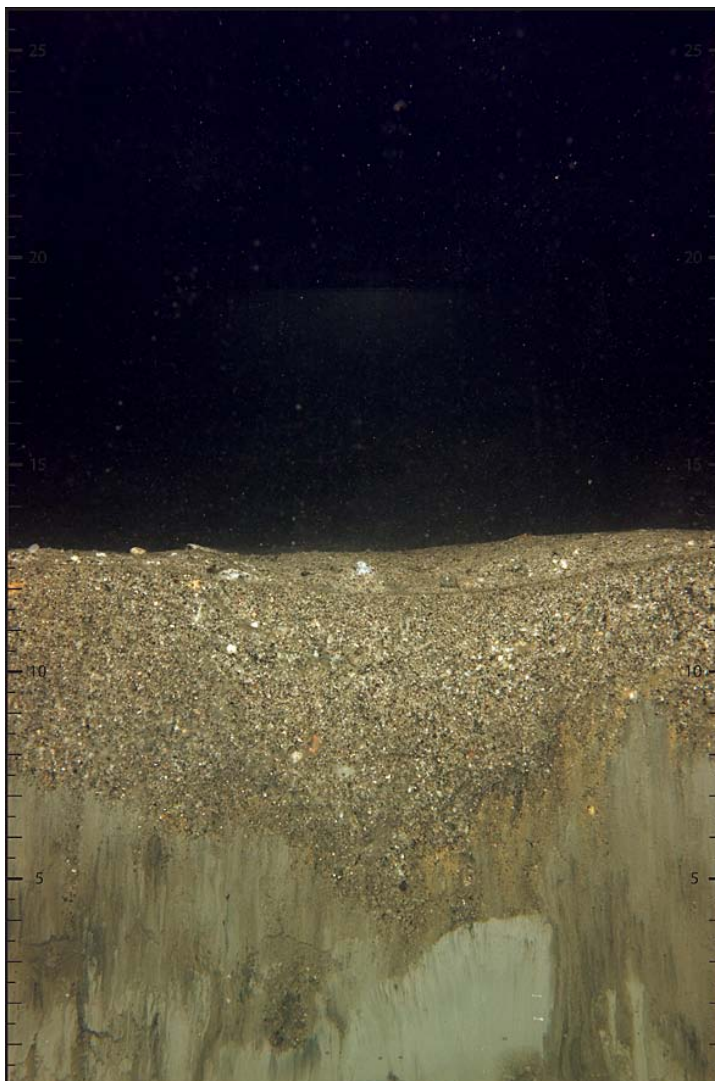
Image ID 4151  
OH454\_1.jpg

| Penetration depth (cm) | 13,0 | Cap crest (cm) | 0,0 |
| Sediment roughness (cm) | 0,5 | Cap area (cm <sup>2</sup> ) | 96,0 |
| SPI weight SPI | 16,8 kg | Cap thickness (cm) | 5,5 |

Color sediment layer 1 Lysgrå  
Color sediment layer 2

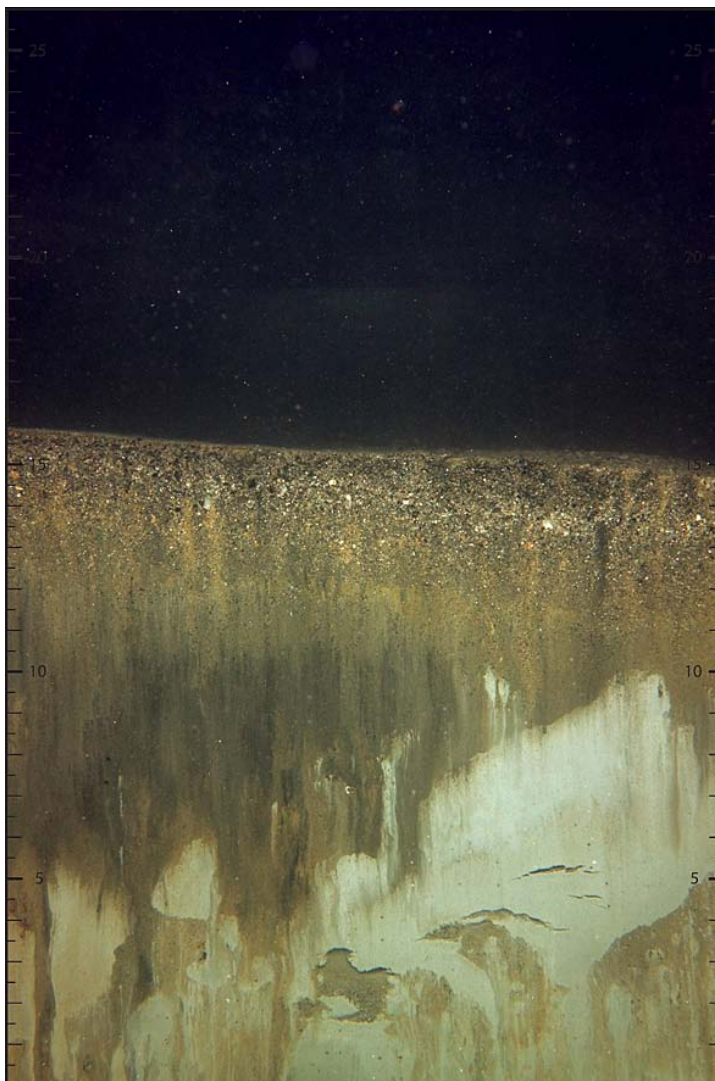
Image ID 4152  
OH455\_1.jpg

Penetration depth (cm) 15,0  
Sediment roughness (cm) 1,0  
SPI weight SPI 26 kg

Cap crest (cm) 0,0  
Cap area (cm<sup>2</sup>) 50,0  
Cap thickness (cm) 2,9

Color sediment layer 1 Mørkgrå  
Color sediment layer 2 Lysgrå

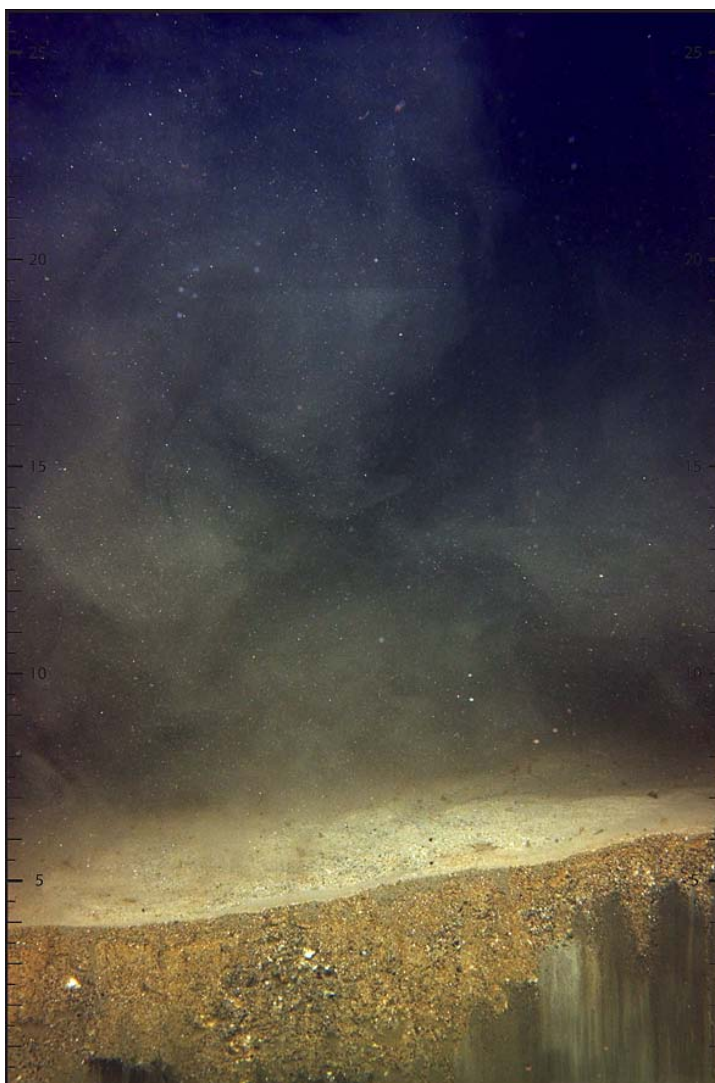
Image ID 4128  
 OH468\_2.jpg

| Penetration depth (cm) | 5,0 | Cap crest (cm) | 0,0 |
| Sediment roughness (cm) | 2,0 | Cap area (cm <sup>2</sup> ) | 54,0 |
| SPI weight SPI 26 kg | | Cap thickness (cm) | 3,1 |

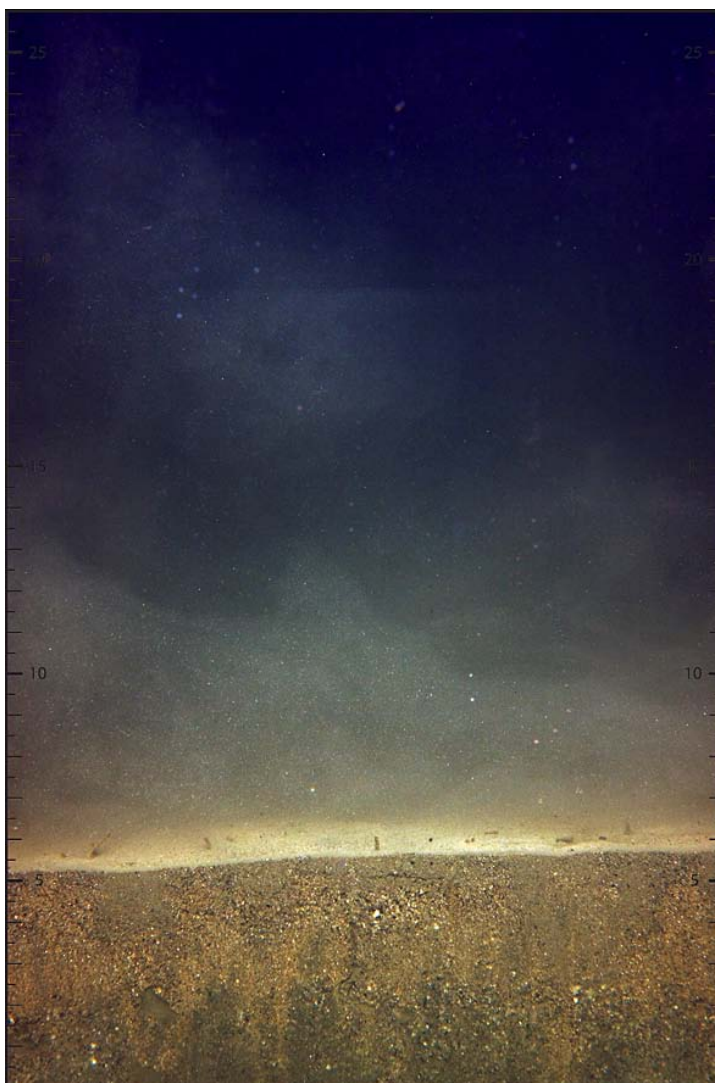
Penetration depth (cm) 5,5  
 Sediment roughness (cm) 0,0  
 SPI weight SPI 26 kg

Cap crest (cm) 0,0  
 Cap area (cm<sup>2</sup>) 90,0  
 Cap thickness (cm) 5,2

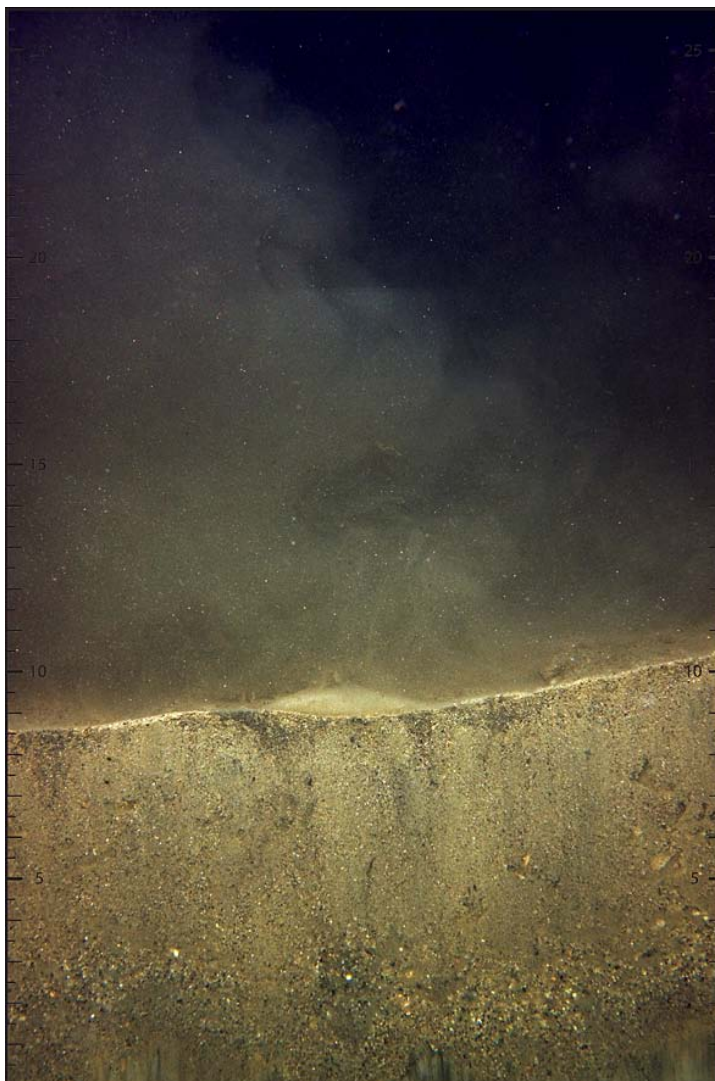
| Penetration depth (cm) | 9,5 | Cap crest (cm) | 0,0 |
| Sediment roughness (cm) | 1,5 | Cap area (cm <sup>2</sup> ) | 153,0 |

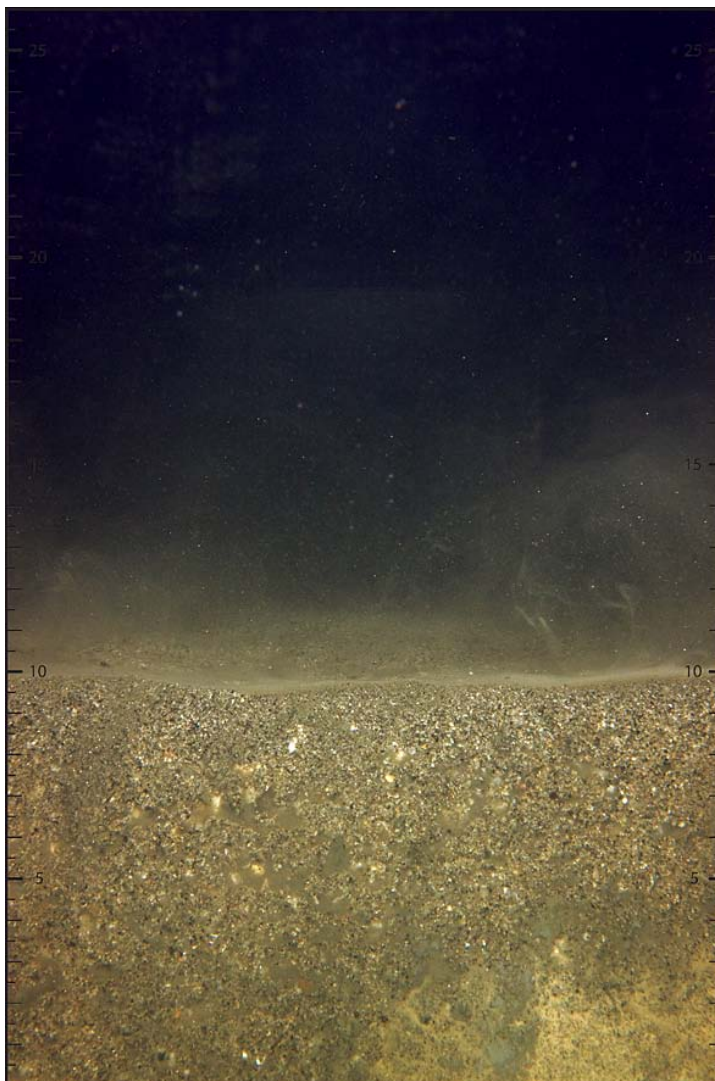
| Penetration depth (cm) | 10,0 | Cap crest (cm) | 0,0 |
| Sediment roughness (cm) | 0,0 | Cap area (cm <sup>2</sup> ) | 173,0 |

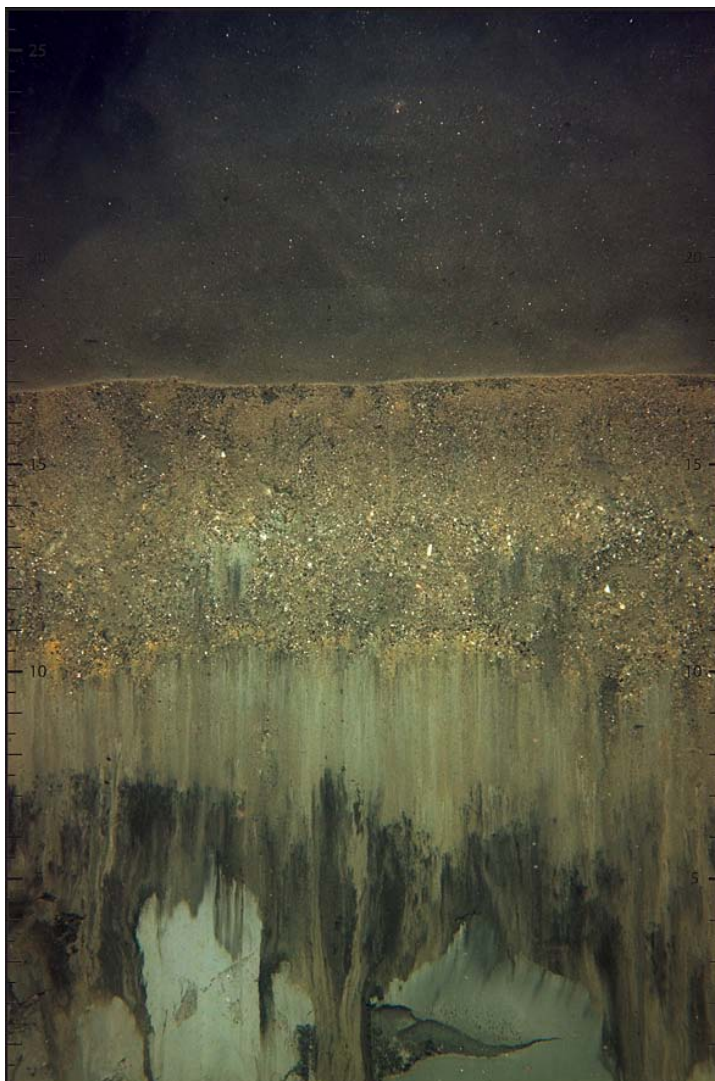
Penetration depth (cm) 17,0  
Sediment roughness (cm) 0,0  
SPI weight SPI 26 kg

Cap crest (cm) 0,0  
Cap area (cm<sup>2</sup>) 118,0  
Cap thickness (cm) 6,8

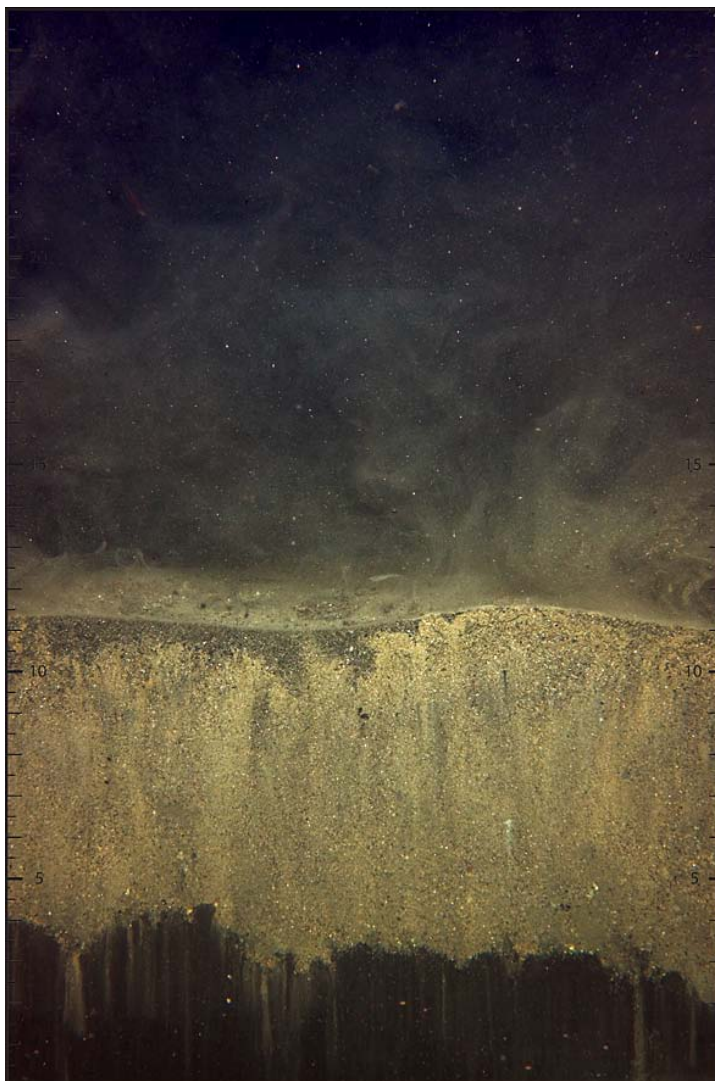
| Penetration depth (cm) | 11,5 | Cap crest (cm) | 0,0 |
| Sediment roughness (cm) | 0,5 | Cap area (cm <sup>2</sup> ) | 124,0 |

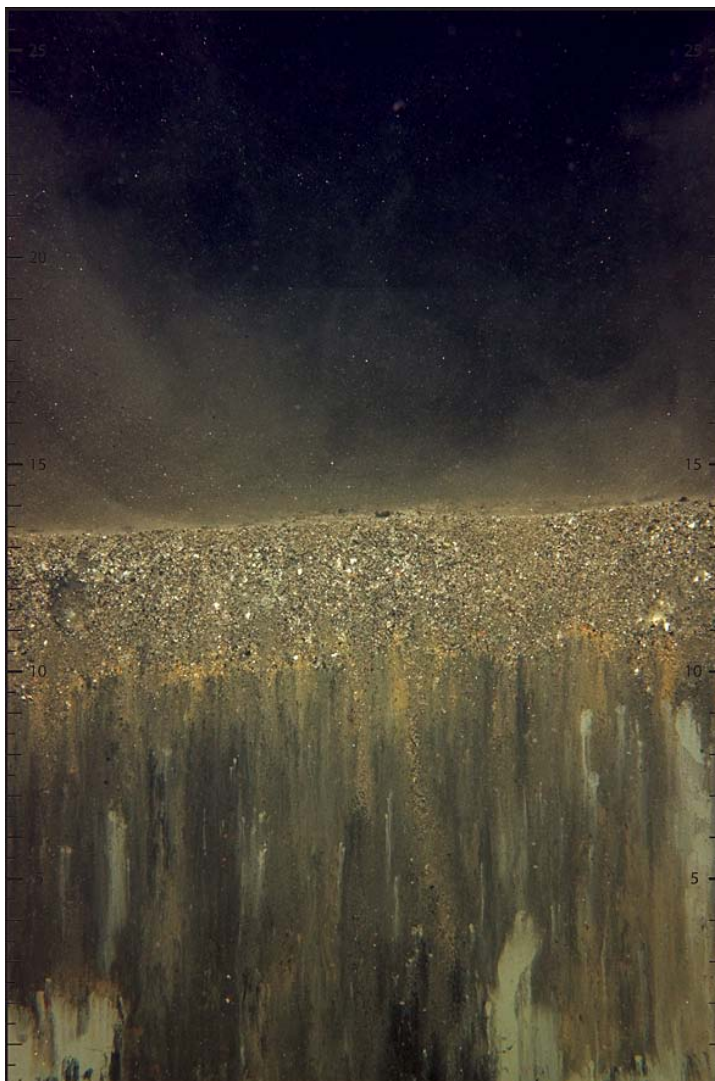
Image ID 4157  
 OH475\_1.jpg

Penetration depth (cm) 13,5 Cap crest (cm) 0,0  
 Sediment roughness (cm) 0,0 Cap area (cm<sup>2</sup>) 61,0  
 SPI weight SPI 26 kg Cap thickness (cm) 3,5

Color sediment layer 1 Mørkgrå  
 Color sediment layer 2 Lysgrå
