# Undersøkelse av tildekking av dypvannsdeponiet ved Malmøy- kalven med Sedimentprofilkamera

| <b>Tittel</b><br><br>Undersøkelse av tildekking av dypvannsdeponiet ved Malmøykalven med Sedimentprofilkamera | <b>Løpenr. (for bestilling)</b><br>5775-2009 | <b>Dato</b><br>31-03-2009 |

| <b>Oppdragsgiver(e)</b><br>Norges Geotekniske Institutt (NGI) | <b>Oppdragsreferanse</b><br>Arne Pettersen og Espen Eek |

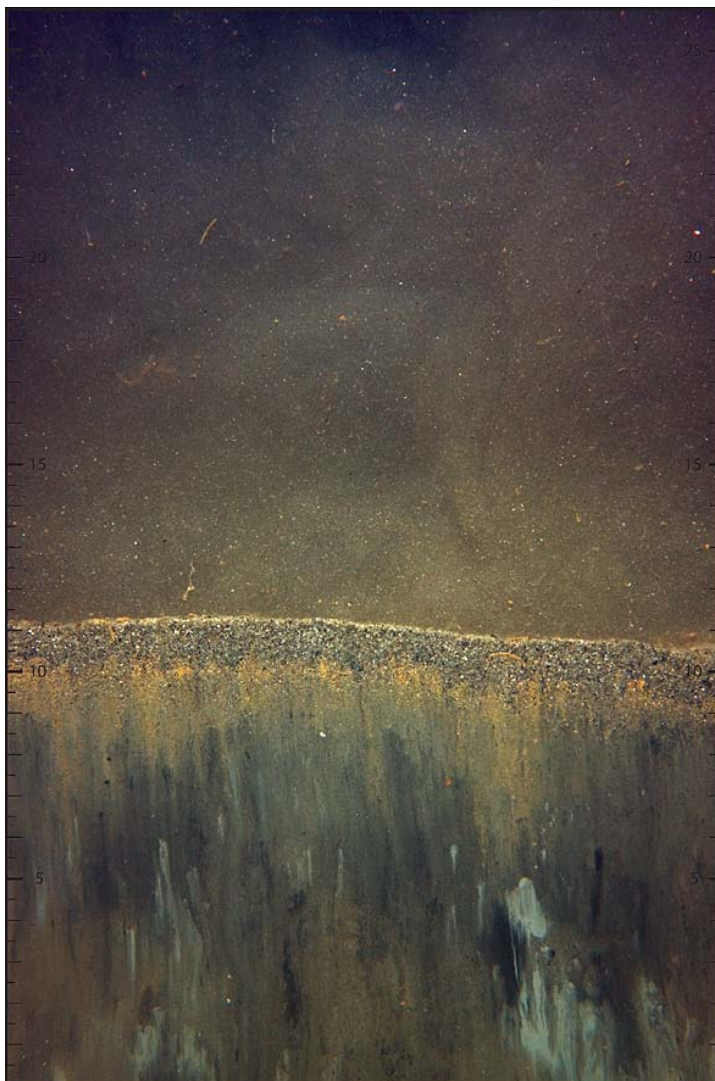
| Penetration depth (cm) | 11,0 | Cap crest (cm) | 0,0 |
| Sediment roughness (cm) | 0,5 | Cap area (cm <sup>2</sup> ) | 17,0 |

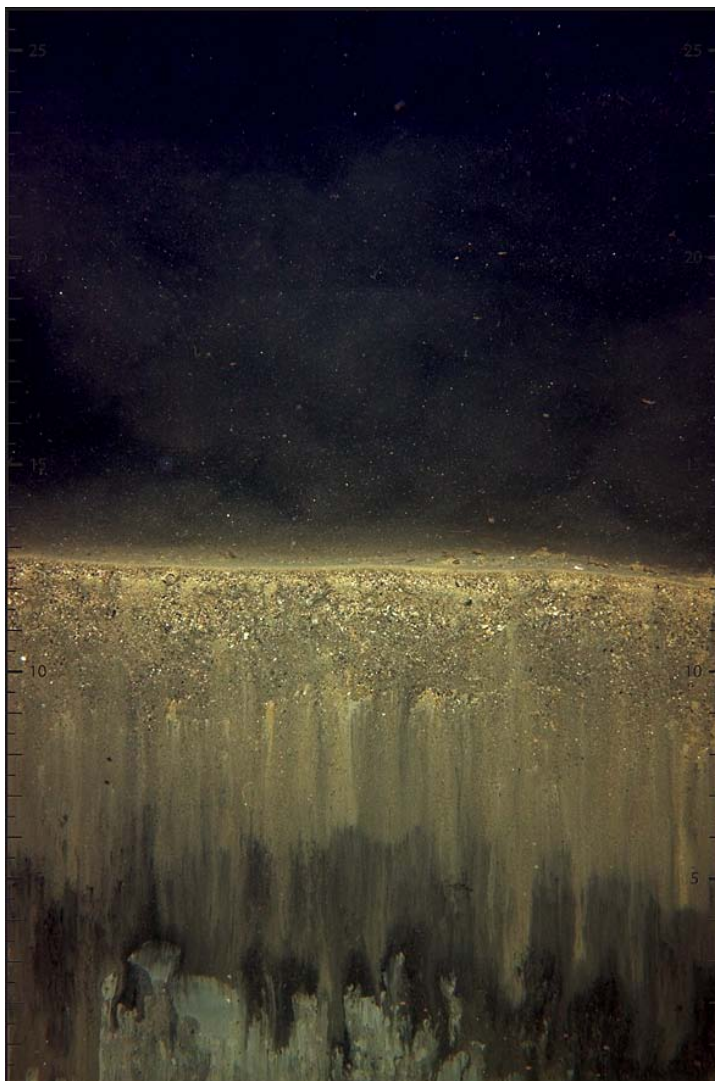
| Penetration depth (cm) | 12,0 | Cap crest (cm) | 0,0 |
| Sediment roughness (cm) | 0,0 | Cap area (cm <sup>2</sup> ) | 55,0 |

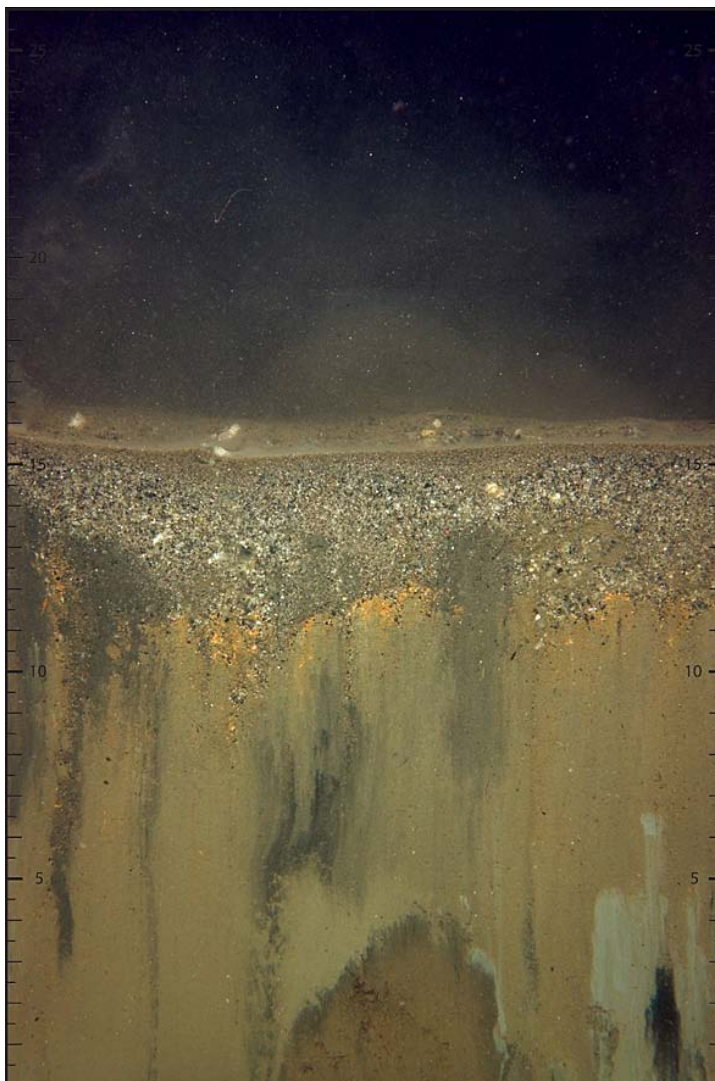
Image ID 4160  
 OH495\_2.jpg

Penetration depth (cm) 15,5 Cap crest (cm) 0,0  
 Sediment roughness (cm) 0,0 Cap area (cm<sup>2</sup>) 60,0  
 SPI weight SPI 26 kg Cap thickness (cm) 3,5

Color sediment layer 1 Mørkgrå  
 Color sediment layer 2

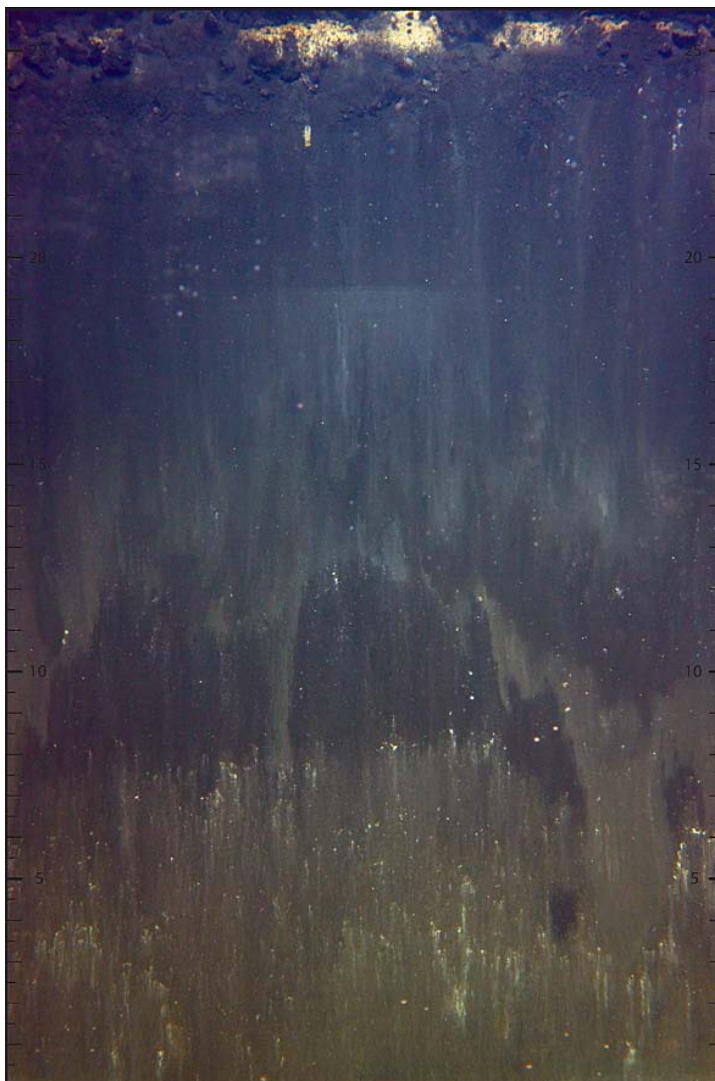
| Penetration depth (cm) | 26,0 | Cap crest (cm) | |
| Sediment roughness (cm) | 0,0 | Cap area (cm <sup>2</sup> ) | 0,0 |
